Access Compliance Report
Public Rights-of-Way
(Curb Ramps)

Intersection ID: 45510	Main Street: WOODLAND_WATCH_CT	Cross Street: MEADOW_BOTTOM_RD	Location:	NW
ADA ID: 855377D688B3	Ramp Type: Perp	Initial Pass/Fail: Pass	Overall Compliance: No	Severity Score: 5

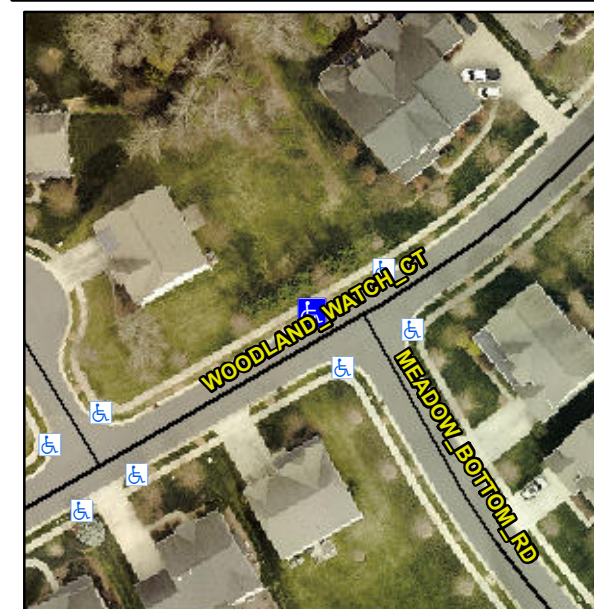
Not Found, R304.5.4

Compliance	Description	Data	Compliance	Description	Data
N/A	Ramp Length (in)	47.0	Yes	Ramp Slope (%)	8.0
Yes	Ramp Width (in)	48.0	Yes	Ramp XSlope (%)	0.9
N/A	Flare Type LT	Sloped	N/A	Flare Type RT	N/A
N/A	Flare Slope LT (%)	2.1	Yes	Flare Slope RT (%)	6.2
N/A	Flare Traversable LT?	Yes	N/A	Flare Traversable RT?	Yes
Yes	Landing Length (in)	48.0	Yes	DWS Provided?	Yes
Yes	Landing Width (in)	48.0	Yes	DWS Contrast?	Yes
Yes	Landing Slope (%)	2.0	Yes	DWS Length (in)	24.0
Yes	Landing X Slope (%)	1.4	Yes	DWS Full Width?	Yes
N/A	Landing Curb? (Y/N)	No	Yes	DWS Offset (in)	2.0
N/A	Shared Landing?	No			
Yes	Gutter Ponding?	No	No	Gutter Slope (%)	8.7
Yes	Gutter Lip Ht (in)	0.0	Yes	Gutter X Slope (%)	1.3
N/A	Painted X Walk1?	No	N/A	Painted X Walk2?	N/A
	X Walk 1 Direction	To SE		X Walk 2 Direction	N/A
N/A	X Walk 1 Width (in)	N/A	N/A	X Walk 2 Width (in)	N/A
	X Walk 1 Slope (%)	2.5		X Walk 2 Slope (%)	N/A
	X Walk 1 X Slope (%)	1.7		X Walk 2 X Slope (%)	N/A

N/A	Ramp inside XWalk1?	N/A	N/A	Ramp inside XWalk2?	N/A
	Road Slope (%)	N/A	N/A	Clear Space?	Yes
	Road X Slope (%)	N/A	N/A	Clear Space to XWalk (in)	N/A
Yes	Any Obstructions?	No	Yes	Storm Grate/Utility Hazard?	No
	Obstruction Type			Storm Grate/Utility Type	
N/A					N/A
			Yes	Surface Condition? (G/P)	Good

Remove & Replace Entire Ramp.
Remove & Replace Gutter.
