# Access Compliance Report
# Public Rights-of-Way
# (Curb Ramps)

| Intersection ID: 10019272 | Main Street: 3RD-4TH_CONNECTOR_ST | Cross Street: N/A | | Location: | W |
| ADA ID: 86923FE33BFB | Ramp Type: Perp | Initial Pass/Fail: Fail | Overall Compliance: No | Severity Score: | 35 |

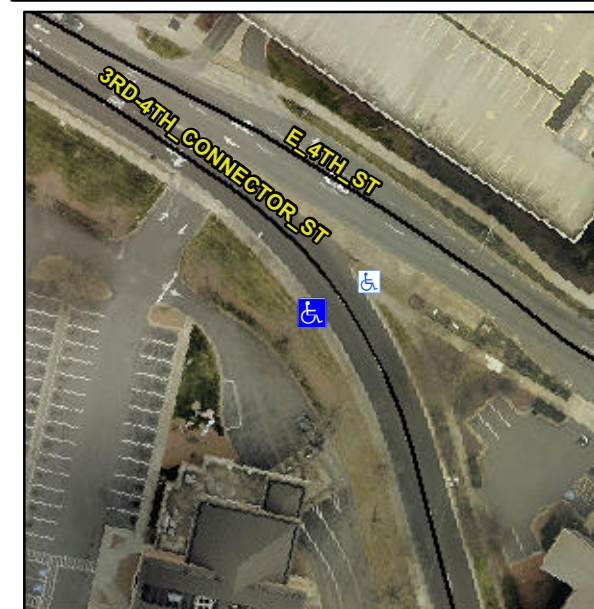
**R304.5.1, R304.2.2**

| Compliance | Description | Data | Compliance | Description | Data |
|---|---|---|---|---|---|
| N/A | Ramp Length (in) | 60.0 | No | Ramp Slope (%) | 12.7 |
| No | Ramp Width (in) | 44.0 | Yes | Ramp XSlope (%) | 3.7 |

**Remove & Replace Entire Ramp.**
