Access Compliance Report
Public Rights-of-Way
(Curb Ramps)

Intersection ID: 30290 **Main Street:** BLACK_KETTLE_DR **Cross Street:** EUROSTAR_DR **Location:** S

ADA ID: 86985CAA040C **Ramp Type:** PerpDiag **Initial Pass/Fail:** Fail **Overall Compliance:** No **Severity Score:** 13.75

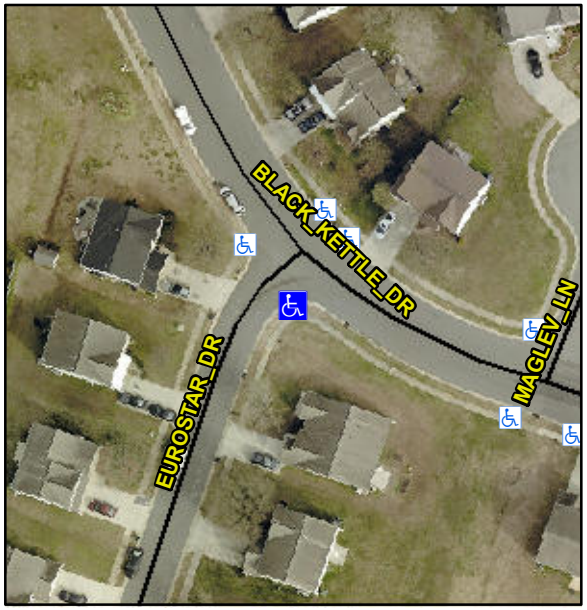
Not Found, R304.2.2, R304.5.3

Compliance	Description	Data	Compliance	Description	Data
N/A	Ramp Length (in)	44.5	No	Ramp Slope (%)	11.7
Yes	Ramp Width (in)	48.0	No	Ramp XSlope (%)	4.9
N/A	Flare Type LT	N/A	N/A	Flare Type RT	N/A
N/A	Flare Slope LT (%)	N/A	N/A	Flare Slope RT (%)	N/A
N/A	Flare Traversable LT?	N/A	N/A	Flare Traversable RT?	N/A
N/A	Landing Length (in)	N/A	N/A	DWS Provided?	N/A
N/A	Landing Width (in)	N/A	N/A	DWS Contrast?	N/A
N/A	Landing Slope (%)	N/A	N/A	DWS Length (in)	N/A
N/A	Landing X Slope (%)	N/A	N/A	DWS Full Width?	N/A
N/A	Landing Curb? (Y/N)	N/A	N/A	DWS Offset (in)	N/A
N/A	Shared Landing?	N/A			
N/A	Gutter Ponding?	N/A	N/A	Gutter Slope (%)	N/A
N/A	Gutter Lip Ht (in)	N/A	N/A	Gutter X Slope (%)	N/A
N/A	Painted X Walk1?	No	N/A	Painted X Walk2?	No
	X Walk 1 Direction	To NE		X Walk 2 Direction	To NW
N/A	X Walk 1 Width (in)	N/A	N/A	X Walk 2 Width (in)	N/A
	X Walk 1 Slope (%)	1.2		X Walk 2 Slope (%)	2.4
	X Walk 1 X Slope (%)	3.6		X Walk 2 X Slope (%)	2.3

Remove & Replace Curb Ramp With Two New Directional Ramps or Equivalent.
