# Access Compliance Report
Public Rights-of-Way
(Curb Ramps)

Intersection ID: 10039648	Main Street: THRIFTWOOD_DR	Cross Street: N/A	Location:	E
ADA ID: 869BEE0983A9	Ramp Type: Perp	Initial Pass/Fail: Fail	Overall Compliance: No	Severity Score: 13.75

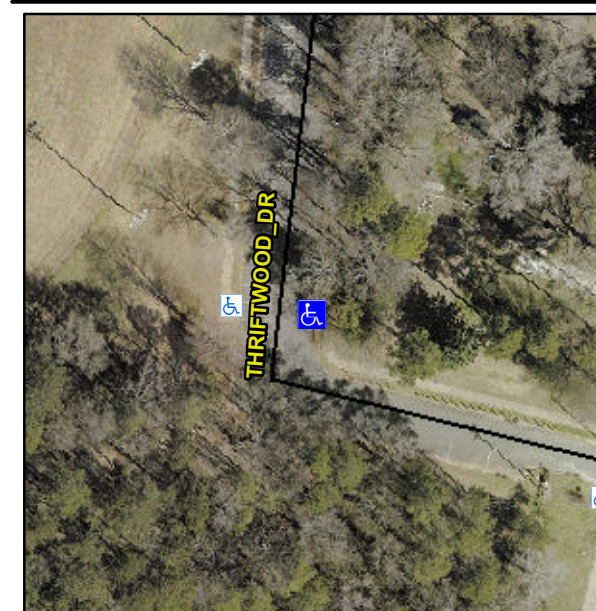
Not Found, R304.2.2, R304.5.3

Compliance	Description	Data	Compliance	Description	Data
N/A	Ramp Length (in)	48.0	No	Ramp Slope (%)	8.8
Yes	Ramp Width (in)	48.0	No	Ramp XSlope (%)	2.9
N/A	Flare Type LT	N/A	N/A	Flare Type RT	N/A
N/A	Flare Slope LT (%)	N/A	N/A	Flare Slope RT (%)	N/A
N/A	Flare Traversable LT?	N/A	N/A	Flare Traversable RT?	N/A
N/A	Landing Length (in)	N/A	N/A	DWS Provided?	N/A
N/A	Landing Width (in)	N/A	N/A	DWS Contrast?	N/A
N/A	Landing Slope (%)	N/A	N/A	DWS Length (in)	N/A
N/A	Landing X Slope (%)	N/A	N/A	DWS Full Width?	N/A
N/A	Landing Curb? (Y/N)	N/A	N/A	DWS Offset (in)	N/A
N/A	Shared Landing?	N/A			
N/A	Gutter Ponding?	N/A	N/A	Gutter Slope (%)	N/A
N/A	Gutter Lip Ht (in)	1.0	N/A	Gutter X Slope (%)	N/A
N/A	Painted X Walk1?	No	N/A	Painted X Walk2?	N/A
	X Walk 1 Direction	To W		X Walk 2 Direction	N/A
N/A	X Walk 1 Width (in)	N/A	N/A	X Walk 2 Width (in)	N/A
	X Walk 1 Slope (%)	3.8		X Walk 2 Slope (%)	N/A
	X Walk 1 X Slope (%)	2.8		X Walk 2 X Slope (%)	N/A

N/A	Ramp inside XWalk1?	N/A	N/A	Ramp inside XWalk2?	N/A
	Road Slope (%)	N/A	N/A	Clear Space?	N/A
	Road X Slope (%)	N/A	N/A	Clear Space to XWalk (in)	N/A
N/A	Any Obstructions?	N/A	N/A	Storm Grate/Utility Hazard?	N/A
	Obstruction Type			Storm Grate/Utility Type	
N/A					N/A
			Yes	Surface Condition? (G/P)	Good

Remove & Replace Entire Ramp.
