Access Compliance Report
Public Rights-of-Way
(Curb Ramps)

Intersection ID: 13780	**Main Street:** ELIZABETH_AV	**Cross Street:** N_TORRENCE_ST	**Location:** W
ADA ID: 8AEC1EC98188	**Ramp Type:** Perp	**Initial Pass/Fail:** Fail	**Overall Compliance:** No	**Severity Score:** 8.75

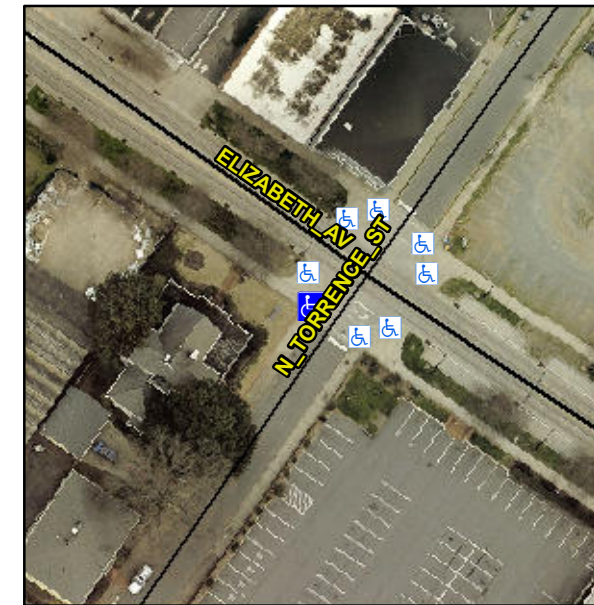
Not Found, R304.5.1

Compliance	Description	Data	Compliance	Description	Data
N/A	Ramp Length (in)	74.0	Yes	Ramp Slope (%)	5.7
No	Ramp Width (in)	47.5	Yes	Ramp XSlope (%)	2.0
N/A	Flare Type LT	N/A	N/A	Flare Type RT	N/A
N/A	Flare Slope LT (%)	N/A	N/A	Flare Slope RT (%)	N/A
N/A	Flare Traversable LT?	N/A	N/A	Flare Traversable RT?	N/A
N/A	Landing Length (in)	N/A	N/A	DWS Provided?	N/A
N/A	Landing Width (in)	N/A	N/A	DWS Contrast?	N/A
N/A	Landing Slope (%)	N/A	N/A	DWS Length (in)	N/A
N/A	Landing X Slope (%)	N/A	N/A	DWS Full Width?	N/A
N/A	Landing Curb? (Y/N)	N/A	N/A	DWS Offset (in)	N/A
N/A	Shared Landing?	N/A			
N/A	Gutter Ponding?	N/A	N/A	Gutter Slope (%)	N/A
N/A	Gutter Lip Ht (in)	N/A	N/A	Gutter X Slope (%)	N/A
N/A	Painted X Walk1?	Yes	N/A	Painted X Walk2?	N/A
	X Walk 1 Direction	To SE		X Walk 2 Direction	N/A
N/A	X Walk 1 Width (in)	116.5	N/A	X Walk 2 Width (in)	N/A
	X Walk 1 Slope (%)	4.7		X Walk 2 Slope (%)	N/A
	X Walk 1 X Slope (%)	1.2		X Walk 2 X Slope (%)	N/A

Remove & Replace Entire Ramp.
