Access Compliance Report

# Public Rights-of-Way
(Curb Ramps)

Intersection ID: 50597	Main Street: DOWNY_BIRCH_RD	Cross Street: GRAY_WILLOW_RD	Location:	NE
ADA ID: 8B9A879E7C63	Ramp Type: Perp	Initial Pass/Fail: Pass	Overall Compliance: No	Severity Score: 0

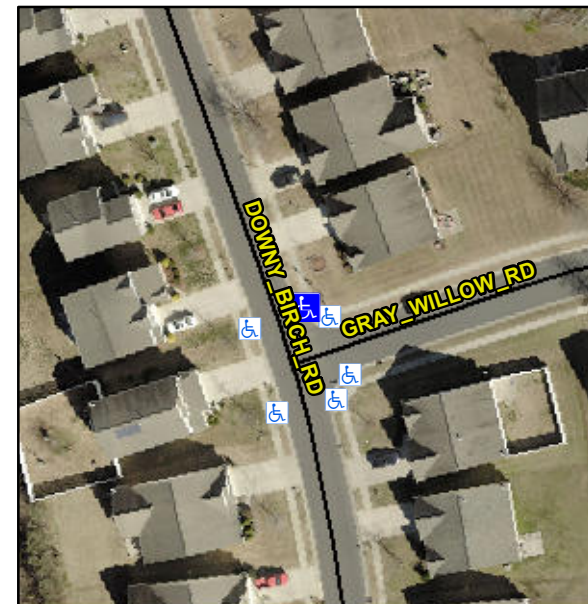
Not Found, R304.2.1, R304.2.2-Perp, R304.3.2-Para, R305.2

Compliance	Description	Data	Compliance	Description	Data
N/A	Ramp Length (in)	48.0	Yes	Ramp Slope (%)	6.7
Yes	Ramp Width (in)	48.0	Yes	Ramp XSlope (%)	1.2
N/A	Flare Type LT	Sloped	N/A	Flare Type RT	N/A
N/A	Flare Slope LT (%)	3.8	N/A	Flare Slope RT (%)	6.9
N/A	Flare Traversable LT?	No	N/A	Flare Traversable RT?	No
No	Landing Length (in)	47.5	Yes	DWS Provided?	Yes
Yes	Landing Width (in)	68.0	Yes	DWS Contrast?	Yes
No	Landing Slope (%)	2.9	Yes	DWS Length (in)	24.0
Yes	Landing X Slope (%)	1.6	Yes	DWS Full Width?	Yes
N/A	Landing Curb? (Y/N)	No	No	DWS Offset (in)	5.5
N/A	Shared Landing?	Yes			
Yes	Gutter Ponding?	No	Yes	Gutter Slope (%)	3.6
Yes	Gutter Lip Ht (in)	0.0	Yes	Gutter X Slope (%)	1.4
N/A	Painted X Walk1?	No	N/A	Painted X Walk2?	N/A
	X Walk 1 Direction	To W		X Walk 2 Direction	N/A
N/A	X Walk 1 Width (in)	N/A	N/A	X Walk 2 Width (in)	N/A
	X Walk 1 Slope (%)	3.2		X Walk 2 Slope (%)	N/A
	X Walk 1 X Slope (%)	0.8		X Walk 2 X Slope (%)	N/A

N/A	Ramp inside XWalk1?	N/A	N/A	Ramp inside XWalk2?	N/A
	Road Slope (%)	N/A	N/A	Clear Space?	Yes
	Road X Slope (%)	N/A	N/A	Clear Space to XWalk (in)	N/A
Yes	Any Obstructions?	No	Yes	Storm Grate/Utility Hazard?	No
	Obstruction Type			Storm Grate/Utility Type	
N/A					N/A
			Yes	Surface Condition? (G/P)	Good

Remove & Replace Entire Ramp.
