Access Compliance Report
Public Rights-of-Way
(Curb Ramps)

Intersection ID: 44307	Main Street: OLIVIA_DIANE_LN	Cross Street: KIEV_DR	Location:	SW
ADA ID: 8D219A2B6C05	Ramp Type: PerpDiag	Initial Pass/Fail: Fail	Overall Compliance: No	Severity Score: 8.75

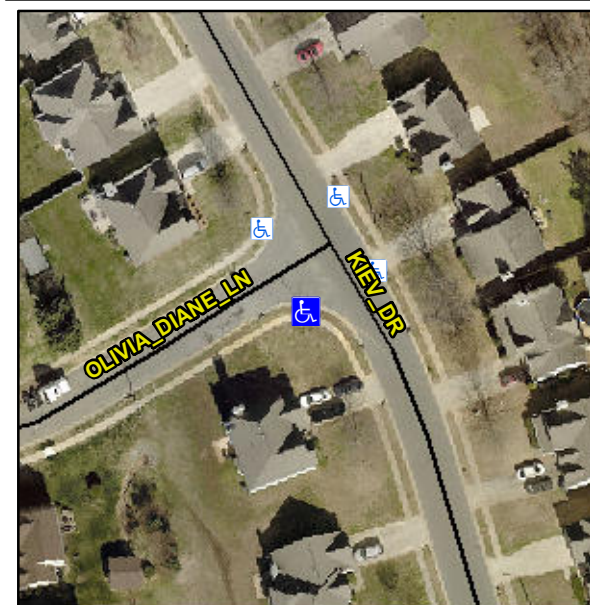
Not Found, R304.5.1

Compliance	Description	Data	Compliance	Description	Data
N/A	Ramp Length (in)	48.0	Yes	Ramp Slope (%)	6.0
No	Ramp Width (in)	41.0	Yes	Ramp XSlope (%)	0.6
N/A	Flare Type LT	N/A	N/A	Flare Type RT	N/A
N/A	Flare Slope LT (%)	N/A	N/A	Flare Slope RT (%)	N/A
N/A	Flare Traversable LT?	N/A	N/A	Flare Traversable RT?	N/A
N/A	Landing Length (in)	N/A	N/A	DWS Provided?	N/A
N/A	Landing Width (in)	N/A	N/A	DWS Contrast?	N/A
N/A	Landing Slope (%)	N/A	N/A	DWS Length (in)	N/A
N/A	Landing X Slope (%)	N/A	N/A	DWS Full Width?	N/A
N/A	Landing Curb? (Y/N)	N/A	N/A	DWS Offset (in)	N/A
N/A	Shared Landing?	N/A			
N/A	Gutter Ponding?	N/A	N/A	Gutter Slope (%)	N/A
N/A	Gutter Lip Ht (in)	N/A	N/A	Gutter X Slope (%)	N/A
N/A	Painted X Walk1?	No	N/A	Painted X Walk2?	No
	X Walk 1 Direction	To E		X Walk 2 Direction	To N
N/A	X Walk 1 Width (in)	N/A	N/A	X Walk 2 Width (in)	N/A
	X Walk 1 Slope (%)	0.2		X Walk 2 Slope (%)	2.0
	X Walk 1 X Slope (%)	1.5		X Walk 2 X Slope (%)	2.0

Remove & Replace Curb Ramp With Two New Directional Ramps or Equivalent.
