Access Compliance Report
Public Rights-of-Way
(Curb Ramps)

Intersection ID: 11898	**Main Street:** ALLEN_ST	**Cross Street:** E_18TH_ST		**Location:** E
ADA ID: 8D7244D3CD35	**Ramp Type:** PerpDiag	**Initial Pass/Fail:** Fail	**Overall Compliance:** No	**Severity Score:** 1.25

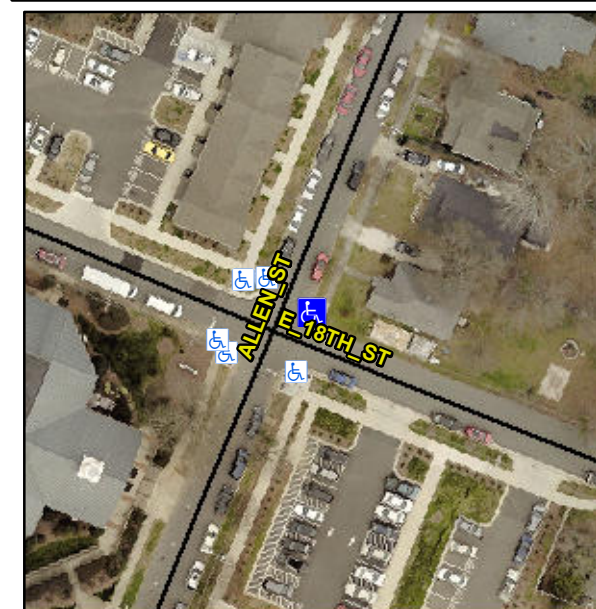
R304.5.3

Compliance	Description	Data	Compliance	Description	Data
N/A	Ramp Length (in)	81.0	Yes	Ramp Slope (%)	5.4
Yes	Ramp Width (in)	55.0	No	Ramp XSlope (%)	2.3
N/A	Flare Type LT	N/A	N/A	Flare Type RT	N/A
N/A	Flare Slope LT (%)	N/A	N/A	Flare Slope RT (%)	N/A
N/A	Flare Traversable LT?	N/A	N/A	Flare Traversable RT?	N/A
N/A	Landing Length (in)	N/A	N/A	DWS Provided?	N/A
N/A	Landing Width (in)	N/A	N/A	DWS Contrast?	N/A
N/A	Landing Slope (%)	N/A	N/A	DWS Length (in)	N/A
N/A	Landing X Slope (%)	N/A	N/A	DWS Full Width?	N/A
N/A	Landing Curb? (Y/N)	N/A	N/A	DWS Offset (in)	N/A
N/A	Shared Landing?	N/A			
N/A	Gutter Ponding?	N/A	N/A	Gutter Slope (%)	N/A
N/A	Gutter Lip Ht (in)	N/A	N/A	Gutter X Slope (%)	N/A
N/A	Painted X Walk1?	No	N/A	Painted X Walk2?	No
	X Walk 1 Direction	To NW		X Walk 2 Direction	To SW
N/A	X Walk 1 Width (in)	N/A	N/A	X Walk 2 Width (in)	N/A
	X Walk 1 Slope (%)	5.8		X Walk 2 Slope (%)	0.6
	X Walk 1 X Slope (%)	0.1		X Walk 2 X Slope (%)	2.3

Remove & Replace Curb Ramp With Two New Directional Ramps or Equivalent.
