Access Compliance Report
Public Rights-of-Way
(Curb Ramps)

Intersection ID: 49291	Main Street: ARDREY_CREST_DR	Cross Street: CHAMBERLIN_RD	Location:	NE
ADA ID: 8D8FD636298E	Ramp Type: PerpDiag	Initial Pass/Fail: Fail	Overall Compliance: No	Severity Score: 21.25

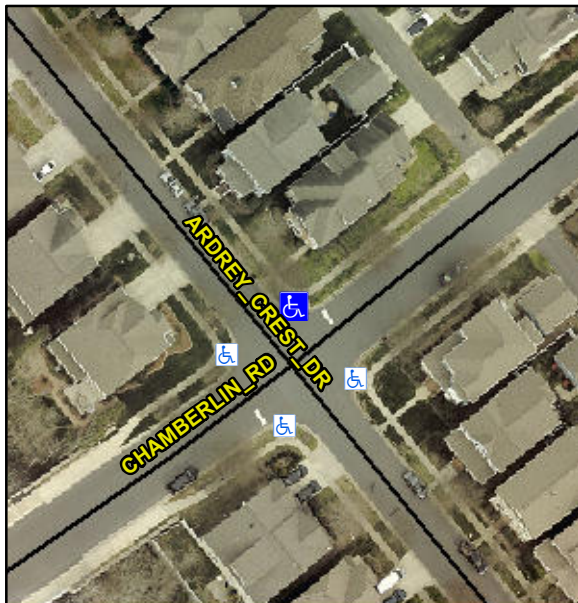
Not Found, R304.5.1, R304.2.2

Compliance	Description	Data	Compliance	Description	Data
N/A	Ramp Length (in)	72.0	No	Ramp Slope (%)	8.8
No	Ramp Width (in)	46.0	Yes	Ramp XSlope (%)	0.9
N/A	Flare Type LT	N/A	N/A	Flare Type RT	N/A
N/A	Flare Slope LT (%)	N/A	N/A	Flare Slope RT (%)	N/A
N/A	Flare Traversable LT?	N/A	N/A	Flare Traversable RT?	N/A
N/A	Landing Length (in)	N/A	N/A	DWS Provided?	N/A
N/A	Landing Width (in)	N/A	N/A	DWS Contrast?	N/A
N/A	Landing Slope (%)	N/A	N/A	DWS Length (in)	N/A
N/A	Landing X Slope (%)	N/A	N/A	DWS Full Width?	N/A
N/A	Landing Curb? (Y/N)	N/A	N/A	DWS Offset (in)	N/A
N/A	Shared Landing?	N/A			
N/A	Gutter Ponding?	N/A	N/A	Gutter Slope (%)	N/A
N/A	Gutter Lip Ht (in)	N/A	N/A	Gutter X Slope (%)	N/A
N/A	Painted X Walk1?	No	N/A	Painted X Walk2?	No
	X Walk 1 Direction	To SW		X Walk 2 Direction	To SE
N/A	X Walk 1 Width (in)	N/A	N/A	X Walk 2 Width (in)	N/A
	X Walk 1 Slope (%)	4.4		X Walk 2 Slope (%)	2.6
	X Walk 1 X Slope (%)	0.1		X Walk 2 X Slope (%)	3.1

Remove & Replace Curb Ramp With Two New Directional Ramps or Equivalent.
