Access Compliance Report
Public Rights-of-Way
(Curb Ramps)

Intersection ID: 5264	**Main Street: BEATTIES_FORD_RD**	**Cross Street: MCINTYRE_AV**	**Location: NE**
ADA ID: 8DB445B2AF6C	**Ramp Type: Perpendicular Diagonal**	**Initial Pass/Fail: Pass**	**Overall Compliance: No**	**Severity Score: 1.25**

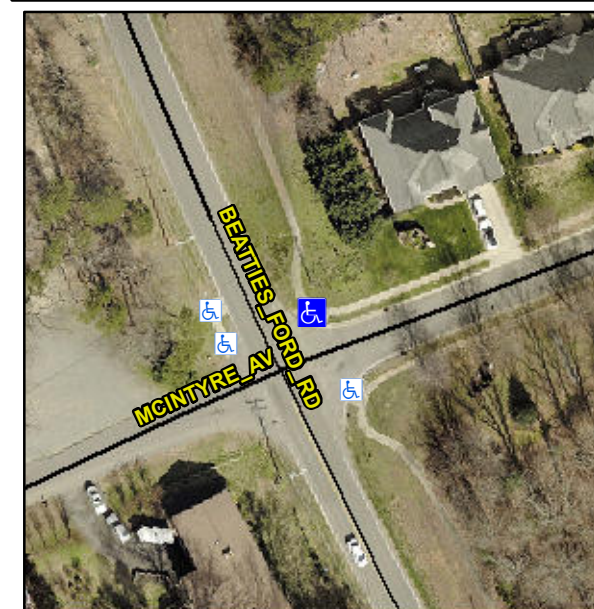
R304.5.1, R304.2.1, R304.5.4, R304.5.3

Compliance	Description	Data	Compliance	Description	Data
N/A	Ramp Length (in)	47.0	Yes	Ramp Slope (%)	4.3
No	Ramp Width (in)	41.5	Yes	Ramp XSlope (%)	1.2
N/A	Flare Type LT	Sloped	N/A	Flare Type RT	N/A
N/A	Flare Slope LT (%)	N/A	N/A	Flare Slope RT (%)	N/A
N/A	Flare Traversable LT?	No	N/A	Flare Traversable RT?	No
Yes	Landing Length (in)	55.5	Yes	DWS Provided?	Yes
No	Landing Width (in)	36.0	Yes	DWS Contrast?	Yes
Yes	Landing Slope (%)	1.6	Yes	DWS Length (in)	24.0
Yes	Landing X Slope (%)	0.8	Yes	DWS Full Width?	Yes
N/A	Landing Curb? (Y/N)	No	Yes	DWS Offset (in)	0.0
N/A	Shared Landing?	No			
Yes	Gutter Ponding?	No	No	Gutter Slope (%)	N/A
Yes	Gutter Lip Ht (in)	0.0	No	Gutter X Slope (%)	N/A
N/A	Painted X Walk1?	No	N/A	Painted X Walk2?	No
	X Walk 1 Direction	To W		X Walk 2 Direction	To S
N/A	X Walk 1 Width (in)	N/A	N/A	X Walk 2 Width (in)	N/A
	X Walk 1 Slope (%)	3.6		X Walk 2 Slope (%)	0.4
	X Walk 1 X Slope (%)	1.6		X Walk 2 X Slope (%)	0.6

Remove & Replace Curb Ramp With Two New Directional Ramps or Equivalent. Remove & Replace Gutter.
