Access Compliance Report
Public Rights-of-Way
(Curb Ramps)

Intersection ID: 7466	**Main Street:** S_I-85_EXIT_39_RA	**Cross Street:** STATESVILLE_RD	**Location:** NW
ADA ID: 8F8568F46D2F	**Ramp Type:** Perpendicular	**Initial Pass/Fail:** Fail **Overall Compliance:** No	**Severity Score:** 12.5

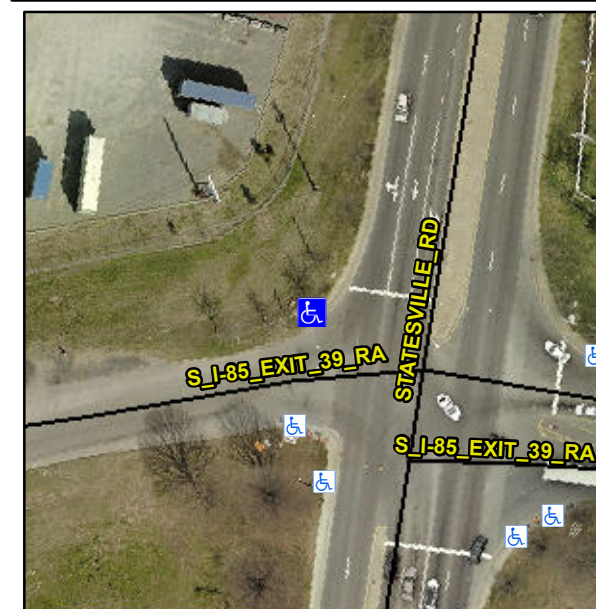
Not Found, R304.2.2

Compliance	Description	Data	Compliance	Description	Data
N/A	Ramp Length (in)	61.5	No	Ramp Slope (%)	8.4
Yes	Ramp Width (in)	48.0	Yes	Ramp XSlope (%)	0.5
N/A	Flare Type LT	N/A	N/A	Flare Type RT	N/A
N/A	Flare Slope LT (%)	N/A	N/A	Flare Slope RT (%)	N/A
N/A	Flare Traversable LT?	N/A	N/A	Flare Traversable RT?	N/A
N/A	Landing Length (in)	N/A	N/A	DWS Provided?	N/A
N/A	Landing Width (in)	N/A	N/A	DWS Contrast?	N/A
N/A	Landing Slope (%)	N/A	N/A	DWS Length (in)	N/A
N/A	Landing X Slope (%)	N/A	N/A	DWS Full Width?	N/A
N/A	Landing Curb? (Y/N)	N/A	N/A	DWS Offset (in)	N/A
N/A	Shared Landing?	N/A			
N/A	Gutter Ponding?	N/A	N/A	Gutter Slope (%)	N/A
N/A	Gutter Lip Ht (in)	0.5	N/A	Gutter X Slope (%)	N/A
N/A	Painted X Walk1?	No	N/A	Painted X Walk2?	N/A
	X Walk 1 Direction	To S		X Walk 2 Direction	N/A
N/A	X Walk 1 Width (in)	N/A	N/A	X Walk 2 Width (in)	N/A
	X Walk 1 Slope (%)	1.2		X Walk 2 Slope (%)	N/A
	X Walk 1 X Slope (%)	0.5		X Walk 2 X Slope (%)	N/A

Remove & Replace Entire Ramp.
