Access Compliance Report
Public Rights-of-Way
(Curb Ramps)

Intersection ID: 9530	Main Street: MCBRIDE_ST	Cross Street: THE_PLAZA	Location:	N
ADA ID: 90897E7C37CC	Ramp Type: PerpDiag	Initial Pass/Fail: Pass	Overall Compliance: No	Severity Score: 27.75

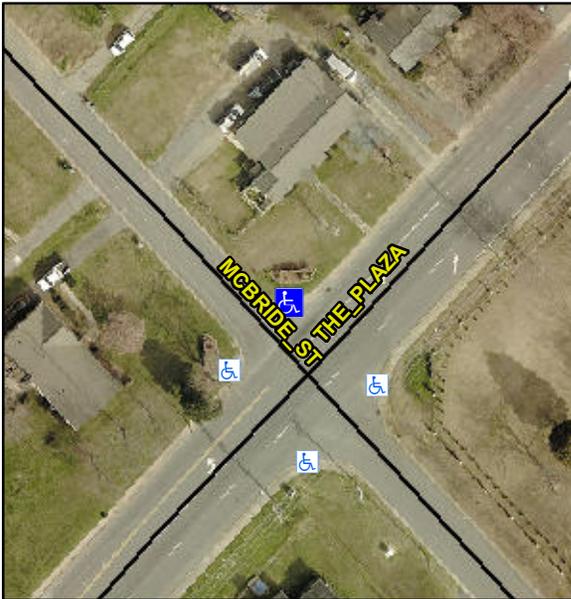
Not Found, R304.5.3, R304.2.1, R304.2.2-Perp, R304.3.2-Para, R305.1.4, R305.2, R302.7, R302.7.2

Compliance	Description	Data	Compliance	Description	Data
N/A	Ramp Length (in)	55.0	Yes	Ramp Slope (%)	7.7
Yes	Ramp Width (in)	54.0	No	Ramp XSlope (%)	2.8
N/A	Flare Type LT	Sloped	N/A	Flare Type RT	N/A
N/A	Flare Slope LT (%)	4.1	Yes	Flare Slope RT (%)	9.8
N/A	Flare Traversable LT?	No	N/A	Flare Traversable RT?	Yes
No	Landing Length (in)	N/A	Yes	DWS Provided?	Yes
No	Landing Width (in)	N/A	Yes	DWS Contrast?	Yes
No	Landing Slope (%)	N/A	Yes	DWS Length (in)	24.0
No	Landing X Slope (%)	N/A	No	DWS Full Width?	No
N/A	Landing Curb? (Y/N)	No	No	DWS Offset (in)	4.0
N/A	Shared Landing?	N/A			
No	Gutter Ponding?	Yes	Yes	Gutter Slope (%)	4.5
No	Gutter Lip Ht (in)	1.0	Yes	Gutter X Slope (%)	1.6
N/A	Painted X Walk1?	No	N/A	Painted X Walk2?	No
	X Walk 1 Direction	To SW		X Walk 2 Direction	To SE
N/A	X Walk 1 Width (in)	N/A	N/A	X Walk 2 Width (in)	N/A
	X Walk 1 Slope (%)	1.6		X Walk 2 Slope (%)	2.5
	X Walk 1 X Slope (%)	0.4		X Walk 2 X Slope (%)	0.8

N/A	Ramp inside XWalk1?	N/A	N/A	Ramp inside XWalk2?	N/A
	Road Slope (%)	2.9	N/A	Clear Space?	Yes
	Road X Slope (%)	2.0	N/A	Clear Space to XWalk (in)	N/A
Yes	Any Obstructions?	No	Yes	Storm Grate/Utility Hazard?	No
	Obstruction Type			Storm Grate/Utility Type	
					N/A
N/A			Yes	Surface Condition? (G/P)	Good

Remove & Replace Curb Ramp With Two New Directional Ramps or Equivalent.
