Access Compliance Report
Public Rights-of-Way
(Curb Ramps)

Intersection ID: 48262	**Main Street:** EAST_ARBORS_DR	**Cross Street:** CLAUDE_FREEMAN_DR	**Location:** E
ADA ID: 91EBC7977293	**Ramp Type:** Perp	**Initial Pass/Fail:** Fail **Overall Compliance:** No	**Severity Score:** 25

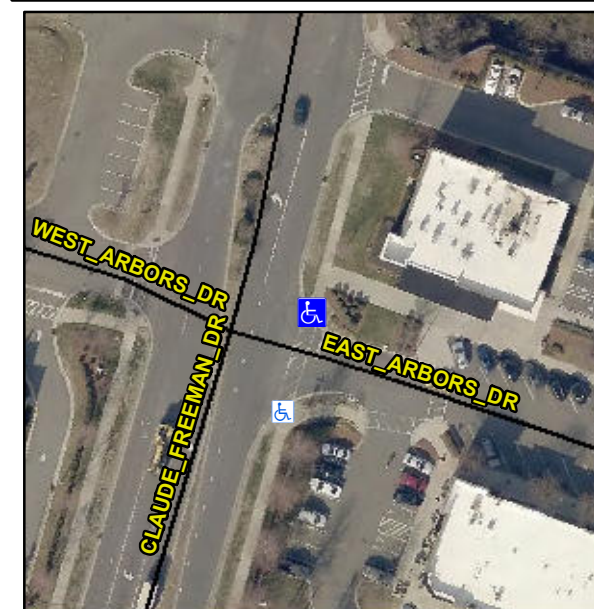
R304.2.2, R304.5.3

Compliance	Description	Data	Compliance	Description	Data
N/A	Ramp Length (in)	49.5	No	Ramp Slope (%)	10.2
Yes	Ramp Width (in)	54.0	No	Ramp XSlope (%)	6.5
N/A	Flare Type LT	N/A	N/A	Flare Type RT	N/A
N/A	Flare Slope LT (%)	N/A	N/A	Flare Slope RT (%)	N/A
N/A	Flare Traversable LT?	N/A	N/A	Flare Traversable RT?	N/A
N/A	Landing Length (in)	N/A	N/A	DWS Provided?	N/A
N/A	Landing Width (in)	N/A	N/A	DWS Contrast?	N/A
N/A	Landing Slope (%)	N/A	N/A	DWS Length (in)	N/A
N/A	Landing X Slope (%)	N/A	N/A	DWS Full Width?	N/A
N/A	Landing Curb? (Y/N)	N/A	N/A	DWS Offset (in)	N/A
N/A	Shared Landing?	N/A			
N/A	Gutter Ponding?	N/A	N/A	Gutter Slope (%)	N/A
N/A	Gutter Lip Ht (in)	N/A	N/A	Gutter X Slope (%)	N/A
N/A	Painted X Walk1?	Yes	N/A	Painted X Walk2?	N/A
	X Walk 1 Direction	To SW		X Walk 2 Direction	N/A
N/A	X Walk 1 Width (in)	89.0	N/A	X Walk 2 Width (in)	N/A
	X Walk 1 Slope (%)	4.5		X Walk 2 Slope (%)	N/A
	X Walk 1 X Slope (%)	0.3		X Walk 2 X Slope (%)	N/A

N/A	Ramp inside XWalk1?	Yes	N/A	Ramp inside XWalk2?	N/A
	Road Slope (%)	N/A	N/A	Clear Space?	N/A
	Road X Slope (%)	N/A	N/A	Clear Space to XWalk (in)	N/A
N/A	Any Obstructions?	N/A	N/A	Storm Grate/Utility Hazard?	N/A
	Obstruction Type			Storm Grate/Utility Type	
N/A					N/A
			Yes	Surface Condition? (G/P)	Good

Remove & Replace Entire Ramp.
