Access Compliance Report
Public Rights-of-Way
(Curb Ramps)

Intersection ID: 12514 **Main Street:** DONALD_ROSS_RD **Cross Street:** WILKINSON_BV **Location:** SE

ADA ID: 93A445AE1C8E **Ramp Type:** Perp **Initial Pass/Fail:** Fail **Overall Compliance:** No **Severity Score:** 21.25

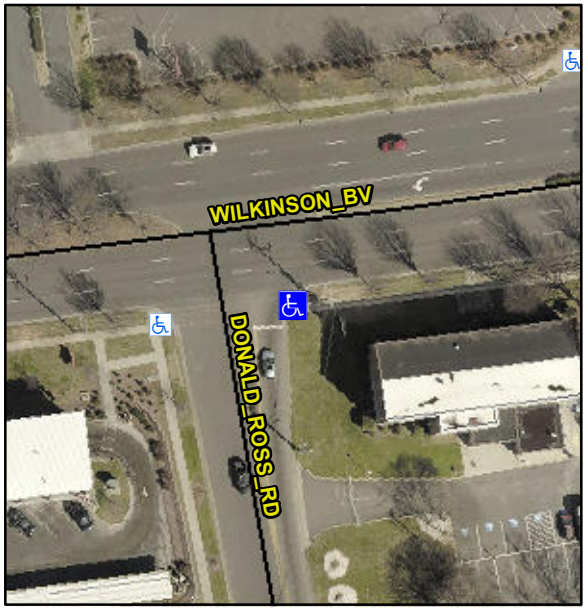
Not Found, R304.5.1, R304.5.3

Compliance	Description	Data	Compliance	Description	Data
N/A	Ramp Length (in)	54.0	Yes	Ramp Slope (%)	5.5
No	Ramp Width (in)	42.0	No	Ramp XSlope (%)	6.0
N/A	Flare Type LT	N/A	N/A	Flare Type RT	N/A
N/A	Flare Slope LT (%)	N/A	N/A	Flare Slope RT (%)	N/A
N/A	Flare Traversable LT?	N/A	N/A	Flare Traversable RT?	N/A
N/A	Landing Length (in)	N/A	N/A	DWS Provided?	N/A
N/A	Landing Width (in)	N/A	N/A	DWS Contrast?	N/A
N/A	Landing Slope (%)	N/A	N/A	DWS Length (in)	N/A
N/A	Landing X Slope (%)	N/A	N/A	DWS Full Width?	N/A
N/A	Landing Curb? (Y/N)	N/A	N/A	DWS Offset (in)	N/A
N/A	Shared Landing?	N/A			
N/A	Gutter Ponding?	N/A	N/A	Gutter Slope (%)	N/A
N/A	Gutter Lip Ht (in)	N/A	N/A	Gutter X Slope (%)	N/A
N/A	Painted X Walk1?	No	N/A	Painted X Walk2?	N/A
	X Walk 1 Direction	To W		X Walk 2 Direction	N/A
N/A	X Walk 1 Width (in)	N/A	N/A	X Walk 2 Width (in)	N/A
	X Walk 1 Slope (%)	0.8		X Walk 2 Slope (%)	N/A

X Walk 1 X Slope (%)	10.4		X Walk 2 X Slope (%)	N/A
N/A	Ramp inside XWalk1?	N/A	N/A	Ramp inside XWalk2?	N/A
	Road Slope (%)	N/A	N/A	Clear Space?	N/A
	Road X Slope (%)	N/A	N/A	Clear Space to XWalk (in)	N/A
N/A	Any Obstructions?	N/A	N/A	Storm Grate/Utility Hazard?	N/A
	Obstruction Type			Storm Grate/Utility Type	
		N/A			N/A
			Yes	Surface Condition? (G/P)	Good

Remove & Replace Entire Ramp.
