Access Compliance Report

# Public Rights-of-Way
(Curb Ramps)

Intersection ID: 21955	Main Street: DELPOND_LN	Cross Street: SUTTON_SPRINGS_RD	Location: N
ADA ID: 93CA97A5AE0B	Ramp Type: PerpDiag	Initial Pass/Fail: Fail	Overall Compliance: No	Severity Score: 10

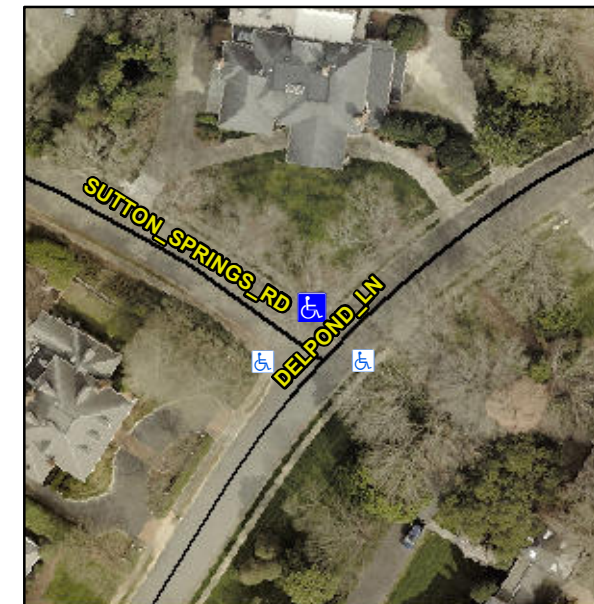
Not Found, R304.5.1, R304.5.3

Compliance	Description	Data	Compliance	Description	Data
N/A	Ramp Length (in)	50.5	Yes	Ramp Slope (%)	5.1
No	Ramp Width (in)	36.0	No	Ramp XSlope (%)	3.0
N/A	Flare Type LT	N/A	N/A	Flare Type RT	N/A
N/A	Flare Slope LT (%)	N/A	N/A	Flare Slope RT (%)	N/A
N/A	Flare Traversable LT?	N/A	N/A	Flare Traversable RT?	N/A
N/A	Landing Length (in)	N/A	N/A	DWS Provided?	N/A
N/A	Landing Width (in)	N/A	N/A	DWS Contrast?	N/A
N/A	Landing Slope (%)	N/A	N/A	DWS Length (in)	N/A
N/A	Landing X Slope (%)	N/A	N/A	DWS Full Width?	N/A
N/A	Landing Curb? (Y/N)	N/A	N/A	DWS Offset (in)	N/A
N/A	Shared Landing?	N/A			
N/A	Gutter Ponding?	N/A	N/A	Gutter Slope (%)	N/A
N/A	Gutter Lip Ht (in)	N/A	N/A	Gutter X Slope (%)	N/A
N/A	Painted X Walk1?	No	N/A	Painted X Walk2?	No
	X Walk 1 Direction	To SW		X Walk 2 Direction	To SE
N/A	X Walk 1 Width (in)	N/A	N/A	X Walk 2 Width (in)	N/A
	X Walk 1 Slope (%)	6.2		X Walk 2 Slope (%)	2.3
	X Walk 1 X Slope (%)	4.3		X Walk 2 X Slope (%)	5.8

Remove & Replace Curb Ramp With Two New Directional Ramps or Equivalent.
