Access Compliance Report
Public Rights-of-Way
(Curb Ramps)

Intersection ID: 43498	**Main Street: DALTREY_LN**	**Cross Street: PRESCOTT_HILL_AV**	**Location:** NW
ADA ID: 93F6DC48CD62	**Ramp Type: PerpDiag**	**Initial Pass/Fail: Fail** **Overall Compliance: No**	**Severity Score:** 22.5

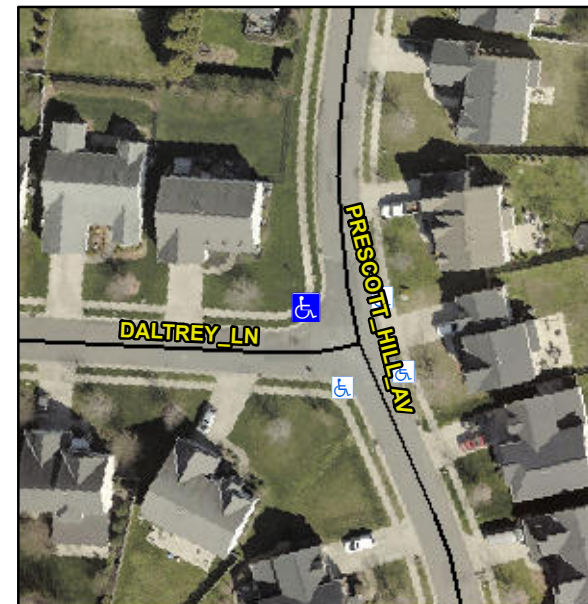
Not Found, R304.5.1, R304.2.2, R304.5.3

Compliance	Description	Data	Compliance	Description	Data
N/A	Ramp Length (in)	48.0	No	Ramp Slope (%)	9.8
No	Ramp Width (in)	42.0	No	Ramp XSlope (%)	4.2
N/A	Flare Type LT	N/A	N/A	Flare Type RT	N/A
N/A	Flare Slope LT (%)	N/A	N/A	Flare Slope RT (%)	N/A
N/A	Flare Traversable LT?	N/A	N/A	Flare Traversable RT?	N/A
N/A	Landing Length (in)	N/A	N/A	DWS Provided?	N/A
N/A	Landing Width (in)	N/A	N/A	DWS Contrast?	N/A
N/A	Landing Slope (%)	N/A	N/A	DWS Length (in)	N/A
N/A	Landing X Slope (%)	N/A	N/A	DWS Full Width?	N/A
N/A	Landing Curb? (Y/N)	N/A	N/A	DWS Offset (in)	N/A
N/A	Shared Landing?	N/A			
N/A	Gutter Ponding?	N/A	N/A	Gutter Slope (%)	N/A
N/A	Gutter Lip Ht (in)	N/A	N/A	Gutter X Slope (%)	N/A
N/A	Painted X Walk1?	No	N/A	Painted X Walk2?	No
	X Walk 1 Direction	To S		X Walk 2 Direction	To E
N/A	X Walk 1 Width (in)	N/A	N/A	X Walk 2 Width (in)	N/A
	X Walk 1 Slope (%)	1.6		X Walk 2 Slope (%)	3.7
	X Walk 1 X Slope (%)	0.9		X Walk 2 X Slope (%)	0.4

N/A	Ramp inside XWalk1?	N/A	N/A	Ramp inside XWalk2?	N/A
	Road Slope (%)	0.8	N/A	Clear Space?	N/A
	Road X Slope (%)	0.8	N/A	Clear Space to XWalk (in)	N/A
N/A	Any Obstructions?	N/A	N/A	Storm Grate/Utility Hazard?	N/A
	Obstruction Type			Storm Grate/Utility Type	
N/A					N/A
			Yes	Surface Condition? (G/P)	Good

Remove & Replace Curb Ramp With Two New Directional Ramps or Equivalent.
