Access Compliance Report
Public Rights-of-Way
(Curb Ramps)

Intersection ID: 14315	Main Street: DRIFTWOOD_DR	Cross Street: ROSEHAVEN_DR	Location:	NE
ADA ID: 945A76CF45F2	Ramp Type: PerpDiag	Initial Pass/Fail: Fail	Overall Compliance: No	Severity Score: 8.75

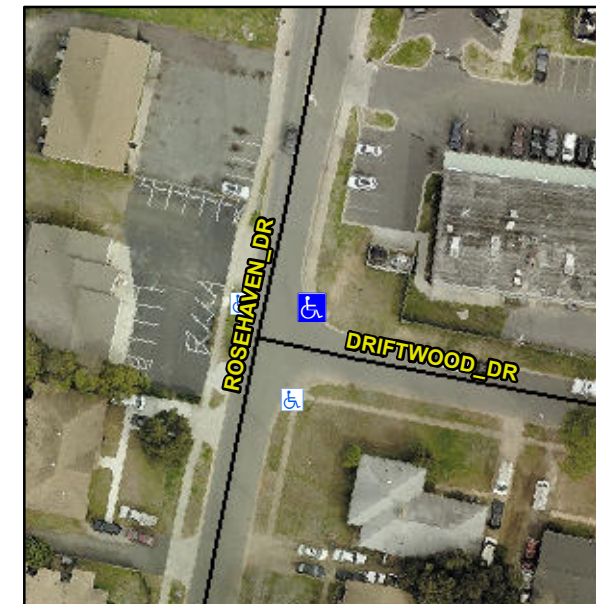
Not Found, R304.5.1

Compliance	Description	Data	Compliance	Description	Data
N/A	Ramp Length (in)	59.0	Yes	Ramp Slope (%)	5.5
No	Ramp Width (in)	47.5	Yes	Ramp XSlope (%)	1.8
N/A	Flare Type LT	N/A	N/A	Flare Type RT	N/A
N/A	Flare Slope LT (%)	N/A	N/A	Flare Slope RT (%)	N/A
N/A	Flare Traversable LT?	N/A	N/A	Flare Traversable RT?	N/A
N/A	Landing Length (in)	N/A	N/A	DWS Provided?	N/A
N/A	Landing Width (in)	N/A	N/A	DWS Contrast?	N/A
N/A	Landing Slope (%)	N/A	N/A	DWS Length (in)	N/A
N/A	Landing X Slope (%)	N/A	N/A	DWS Full Width?	N/A
N/A	Landing Curb? (Y/N)	N/A	N/A	DWS Offset (in)	N/A
N/A	Shared Landing?	N/A			
N/A	Gutter Ponding?	N/A	N/A	Gutter Slope (%)	N/A
N/A	Gutter Lip Ht (in)	N/A	N/A	Gutter X Slope (%)	N/A
N/A	Painted X Walk1?	No	N/A	Painted X Walk2?	No
	X Walk 1 Direction	To NW		X Walk 2 Direction	To SW
N/A	X Walk 1 Width (in)	N/A	N/A	X Walk 2 Width (in)	N/A
	X Walk 1 Slope (%)	1.0		X Walk 2 Slope (%)	4.1
	X Walk 1 X Slope (%)	1.0		X Walk 2 X Slope (%)	0.0

N/A	Ramp inside XWalk1?	N/A	N/A	Ramp inside XWalk2?	N/A
	Road Slope (%)	2.2	N/A	Clear Space?	N/A
	Road X Slope (%)	2.5	N/A	Clear Space to XWalk (in)	N/A
N/A	Any Obstructions?	N/A	N/A	Storm Grate/Utility Hazard?	N/A
	Obstruction Type			Storm Grate/Utility Type	
N/A					N/A
			Yes	Surface Condition? (G/P)	Good

Remove & Replace Curb Ramp With Two New Directional Ramps or Equivalent.
