Access Compliance Report
Public Rights-of-Way
(Curb Ramps)

Intersection ID: 50511	**Main Street:** ALLEN_A_BROWN_RD	**Cross Street:** MERIDALE_CROSSING_DR	**Location:** S
ADA ID: 951EB1C1AE53	**Ramp Type:** PerpDiag	**Initial Pass/Fail:** Fail	**Overall Compliance:** No **Severity Score:** 10

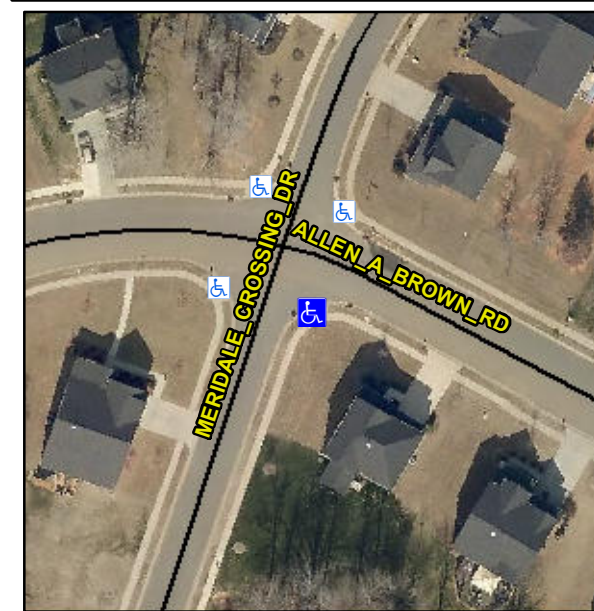
Not Found, R304.5.1, R304.5.3

Compliance	Description	Data	Compliance	Description	Data
N/A	Ramp Length (in)	48.0	Yes	Ramp Slope (%)	6.1
No	Ramp Width (in)	47.0	No	Ramp XSlope (%)	4.5
N/A	Flare Type LT	N/A	N/A	Flare Type RT	N/A
N/A	Flare Slope LT (%)	N/A	N/A	Flare Slope RT (%)	N/A
N/A	Flare Traversable LT?	N/A	N/A	Flare Traversable RT?	N/A
N/A	Landing Length (in)	N/A	N/A	DWS Provided?	N/A
N/A	Landing Width (in)	N/A	N/A	DWS Contrast?	N/A
N/A	Landing Slope (%)	N/A	N/A	DWS Length (in)	N/A
N/A	Landing X Slope (%)	N/A	N/A	DWS Full Width?	N/A
N/A	Landing Curb? (Y/N)	N/A	N/A	DWS Offset (in)	N/A
N/A	Shared Landing?	N/A			
N/A	Gutter Ponding?	N/A	N/A	Gutter Slope (%)	N/A
N/A	Gutter Lip Ht (in)	N/A	N/A	Gutter X Slope (%)	N/A
N/A	Painted X Walk1?	No	N/A	Painted X Walk2?	No
	X Walk 1 Direction	To NE		X Walk 2 Direction	To NW
N/A	X Walk 1 Width (in)	N/A	N/A	X Walk 2 Width (in)	N/A
	X Walk 1 Slope (%)	3.6		X Walk 2 Slope (%)	2.8
	X Walk 1 X Slope (%)	0.7		X Walk 2 X Slope (%)	3.9

Remove & Replace Curb Ramp With Two New Directional Ramps or Equivalent.
