Access Compliance Report
Public Rights-of-Way
(Curb Ramps)

Intersection ID: 13654	Main Street: S_TRYON_ST	Cross Street: W_PARK_AV	Location:	E
ADA ID: 9578CA6AE103	Ramp Type: PerpDiag	Initial Pass/Fail: Fail	Overall Compliance: No	Severity Score: 12.5

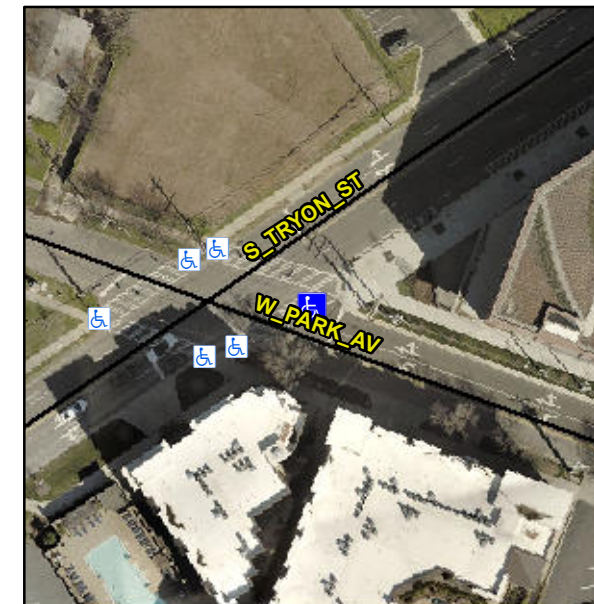
R304.2.2

Compliance	Description	Data	Compliance	Description	Data
N/A	Ramp Length (in)	48.0	No	Ramp Slope (%)	11.5
Yes	Ramp Width (in)	48.0	Yes	Ramp XSlope (%)	0.3
N/A	Flare Type LT	N/A	N/A	Flare Type RT	N/A
N/A	Flare Slope LT (%)	N/A	N/A	Flare Slope RT (%)	N/A
N/A	Flare Traversable LT?	N/A	N/A	Flare Traversable RT?	N/A
N/A	Landing Length (in)	N/A	N/A	DWS Provided?	N/A
N/A	Landing Width (in)	N/A	N/A	DWS Contrast?	N/A
N/A	Landing Slope (%)	N/A	N/A	DWS Length (in)	N/A
N/A	Landing X Slope (%)	N/A	N/A	DWS Full Width?	N/A
N/A	Landing Curb? (Y/N)	N/A	N/A	DWS Offset (in)	N/A
N/A	Shared Landing?	N/A			
N/A	Gutter Ponding?	N/A	N/A	Gutter Slope (%)	N/A
N/A	Gutter Lip Ht (in)	N/A	N/A	Gutter X Slope (%)	N/A
N/A	Painted X Walk1?	Yes	N/A	Painted X Walk2?	Yes
	X Walk 1 Direction	To NW		X Walk 2 Direction	To SW
N/A	X Walk 1 Width (in)	88.0	N/A	X Walk 2 Width (in)	111.0
	X Walk 1 Slope (%)	4.2		X Walk 2 Slope (%)	1.5
	X Walk 1 X Slope (%)	2.2		X Walk 2 X Slope (%)	2.0

Remove & Replace Curb Ramp With Two New Directional Ramps or Equivalent.
