Access Compliance Report
Public Rights-of-Way
(Curb Ramps)

Intersection ID: 17205	**Main Street: LINDA_LN**	**Cross Street: WALKER_RD**	**Location: SW**
ADA ID: 95BD4BC4749D	**Ramp Type: ParaDiag**	**Initial Pass/Fail: Pass** **Overall Compliance: No**	**Severity Score: 4**

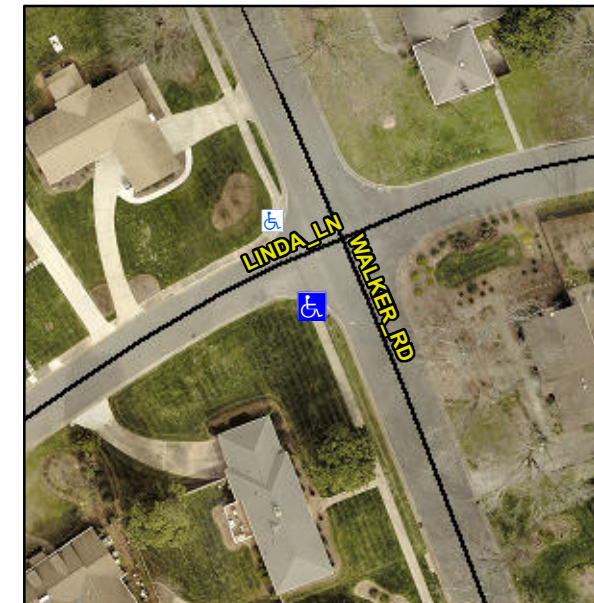
ASP LIP 0.5, RT RP < 5%

Not Found, R304.2.1, R305.2

Compliance	Description	Data	Compliance	Description	Data
N/A	Ramp Length LT (in)	58.0	N/A	Ramp Length RT (in)	63.0
Yes	Ramp Width LT (in)	49.0	Yes	Ramp Width RT (in)	49.0
Yes	Ramp Slope LT (%)	6.6	Yes	Ramp Slope RT (%)	4.2
Yes	Ramp XSlope LT (%)	0.2	Yes	Ramp XSlope RT (%)	2.0
No	Landing Length (in)	47.0	Yes	DWS Provided?	Yes
No	Landing Width (in)	41.0	Yes	DWS Contrast?	Yes
Yes	Landing Slope (%)	1.3	Yes	DWS Length (in)	24.0
Yes	Landing X Slope (%)	1.4	Yes	DWS Full Width?	Yes
N/A	Landing Curb? (Y/N)	No	No	DWS Offset (in)	4.0
N/A	Shared Landing?	No			
Yes	Gutter Ponding?	No	Yes	Gutter Slope (%)	3.2
Yes	Gutter Lip Ht (in)	0.0	Yes	Gutter X Slope (%)	1.7
N/A	Painted X Walk1?	No	N/A	Painted X Walk2?	No
	X Walk 1 Direction	To NE		X Walk 2 Direction	To NW
N/A	X Walk 1 Width (in)	N/A	N/A	X Walk 2 Width (in)	N/A
	X Walk 1 Slope (%)	3.0		X Walk 2 Slope (%)	1.9
	X Walk 1 X Slope (%)	0.9		X Walk 2 X Slope (%)	0.6
N/A	Ramp inside XWalk1?	N/A	N/A	Ramp inside XWalk2?	N/A

Road Slope (%)	0.7	N/A	Clear Space?	Yes
	Road X Slope (%)	7.1	N/A	Clear Space to XWalk (in)	N/A
Yes	Any Obstructions?	No	Yes	Storm Grate/Utility Hazard?	No
	Obstruction Type			Storm Grate/Utility Type	
			N/A		N/A
			Yes	Surface Condition? (G/P)	Good
			Replace Curb Ramp Slope (%)		14.7

Remove & Replace Curb Ramp With Two New Directional Ramps or Equivalent.
