Access Compliance Report
Public Rights-of-Way
(Curb Ramps)

Intersection ID: 51044	Main Street: KENDALL_DR	Cross Street: LONGNOR_ST	Location:	NW
ADA ID: 95DA5D29942A	Ramp Type: PerpDiag	Initial Pass/Fail: Fail	Overall Compliance: No	Severity Score: 12.5

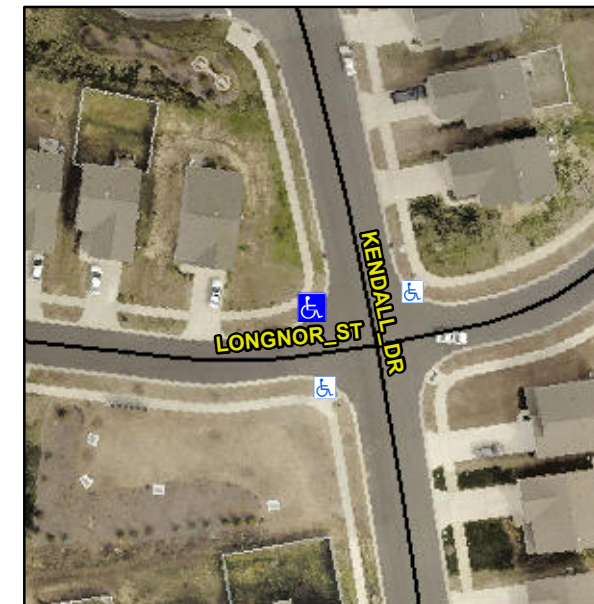
Not Found, R304.5.3

Compliance	Description	Data	Compliance	Description	Data
N/A	Ramp Length (in)	73.0	Yes	Ramp Slope (%)	5.5
Yes	Ramp Width (in)	60.0	No	Ramp XSlope (%)	5.1
N/A	Flare Type LT	N/A	N/A	Flare Type RT	N/A
N/A	Flare Slope LT (%)	N/A	N/A	Flare Slope RT (%)	N/A
N/A	Flare Traversable LT?	N/A	N/A	Flare Traversable RT?	N/A
N/A	Landing Length (in)	N/A	N/A	DWS Provided?	N/A
N/A	Landing Width (in)	N/A	N/A	DWS Contrast?	N/A
N/A	Landing Slope (%)	N/A	N/A	DWS Length (in)	N/A
N/A	Landing X Slope (%)	N/A	N/A	DWS Full Width?	N/A
N/A	Landing Curb? (Y/N)	N/A	N/A	DWS Offset (in)	N/A
N/A	Shared Landing?	N/A			
N/A	Gutter Ponding?	N/A	N/A	Gutter Slope (%)	N/A
N/A	Gutter Lip Ht (in)	N/A	N/A	Gutter X Slope (%)	N/A
N/A	Painted X Walk1?	No	N/A	Painted X Walk2?	No
	X Walk 1 Direction	To S		X Walk 2 Direction	To E
N/A	X Walk 1 Width (in)	N/A	N/A	X Walk 2 Width (in)	N/A
	X Walk 1 Slope (%)	1.2		X Walk 2 Slope (%)	8.2
	X Walk 1 X Slope (%)	5.7		X Walk 2 X Slope (%)	4.8

Remove & Replace Curb Ramp With Two New Directional Ramps or Equivalent.
