Access Compliance Report
Public Rights-of-Way
(Curb Ramps)

Intersection ID: 24596	Main Street: JARDINIERE_CT	Cross Street: SEQUOIA_RED_LN	Location: E
ADA ID: 962559685C03	Ramp Type: PerpDiag	Initial Pass/Fail: Fail	Overall Compliance: No	Severity Score: 25

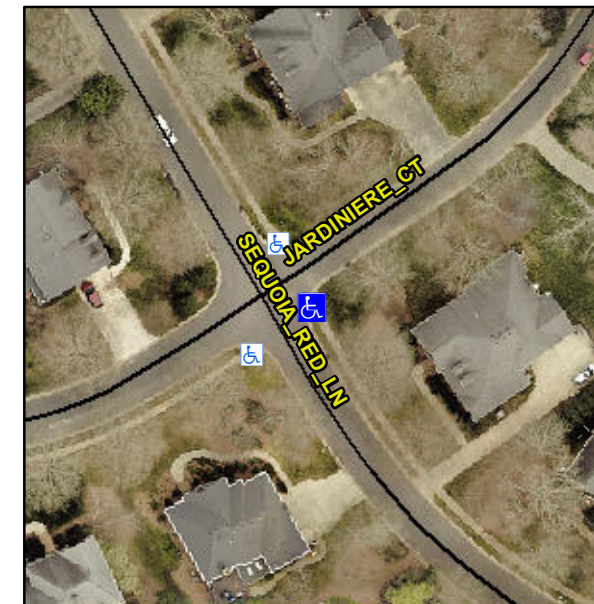
Compliance	Description	Data	Compliance	Description	Data
N/A	Ramp Length (in)	96.0	No	Ramp Slope (%)	9.7
Yes	Ramp Width (in)	58.0	No	Ramp XSlope (%)	6.0
N/A	Flare Type LT	N/A	N/A	Flare Type RT	N/A
N/A	Flare Slope LT (%)	N/A	N/A	Flare Slope RT (%)	N/A
N/A	Flare Traversable LT?	N/A	N/A	Flare Traversable RT?	N/A
N/A	Landing Length (in)	N/A	N/A	DWS Provided?	N/A
N/A	Landing Width (in)	N/A	N/A	DWS Contrast?	N/A
N/A	Landing Slope (%)	N/A	N/A	DWS Length (in)	N/A
N/A	Landing X Slope (%)	N/A	N/A	DWS Full Width?	N/A
N/A	Landing Curb? (Y/N)	N/A	N/A	DWS Offset (in)	N/A
N/A	Shared Landing?	N/A			
N/A	Gutter Ponding?	N/A	N/A	Gutter Slope (%)	N/A
N/A	Gutter Lip Ht (in)	N/A	N/A	Gutter X Slope (%)	N/A
N/A	Painted X Walk1?	No	N/A	Painted X Walk2?	No
	X Walk 1 Direction	To N		X Walk 2 Direction	To SW
N/A	X Walk 1 Width (in)	N/A	N/A	X Walk 2 Width (in)	N/A
	X Walk 1 Slope (%)	4.6		X Walk 2 Slope (%)	2.7
	X Walk 1 X Slope (%)	0.2		X Walk 2 X Slope (%)	4.1

N/A	Ramp inside XWalk1?	N/A	N/A	Ramp inside XWalk2?	N/A
	Road Slope (%)	2.3	N/A	Clear Space?	N/A
	Road X Slope (%)	3.3	N/A	Clear Space to XWalk (in)	N/A
N/A	Any Obstructions?	N/A	N/A	Storm Grate/Utility Hazard?	N/A
	Obstruction Type			Storm Grate/Utility Type	
N/A					N/A
			Yes	Surface Condition? (G/P)	Good

Remove & Replace Curb Ramp With Two New Directional Ramps or Equivalent.
