Access Compliance Report
Public Rights-of-Way
(Curb Ramps)

Intersection ID: 11129	**Main Street: BECKWITH_PL**	**Cross Street: NEWELL_AV**	**Location: SE**
ADA ID: 96659619C51F	**Ramp Type: PerpDiag**	**Initial Pass/Fail: Pass** **Overall Compliance: No**	**Severity Score: 42.5**

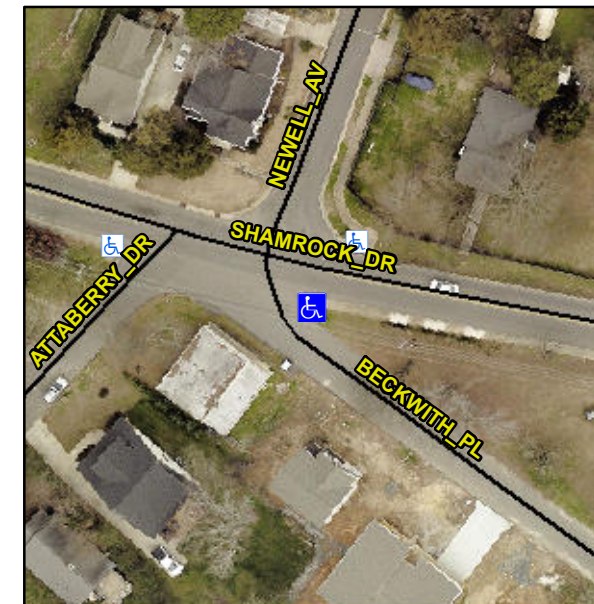
Not Found, R304.5.1, R304.5.3, R304.2.1, R304.2.2-Perp, R304.3.2-Para, R305, R302.7.2, R304.5.4

Compliance	Description	Data	Compliance	Description	Data
N/A	Ramp Length (in)	60.0	Yes	Ramp Slope (%)	7.9
No	Ramp Width (in)	24.0	No	Ramp XSlope (%)	10.0
N/A	Flare Type LT	Sloped	N/A	Flare Type RT	N/A
N/A	Flare Slope LT (%)	8.9	N/A	Flare Slope RT (%)	10.6
N/A	Flare Traversable LT?	Yes	N/A	Flare Traversable RT?	No
No	Landing Length (in)	N/A	No	DWS Provided?	No
No	Landing Width (in)	N/A	N/A	DWS Contrast?	No
No	Landing Slope (%)	N/A	N/A	DWS Length (in)	N/A
No	Landing X Slope (%)	N/A	N/A	DWS Full Width?	No
N/A	Landing Curb? (Y/N)	No	N/A	DWS Offset (in)	N/A
N/A	Shared Landing?	N/A			
Yes	Gutter Ponding?	No	No	Gutter Slope (%)	6.5
No	Gutter Lip Ht (in)	0.5	No	Gutter X Slope (%)	6.8
N/A	Painted X Walk1?	No	N/A	Painted X Walk2?	No
	X Walk 1 Direction	To NW		X Walk 2 Direction	To N
N/A	X Walk 1 Width (in)	N/A	N/A	X Walk 2 Width (in)	N/A
	X Walk 1 Slope (%)	14.4		X Walk 2 Slope (%)	24.3
	X Walk 1 X Slope (%)	3.4		X Walk 2 X Slope (%)	4.1

N/A	Ramp inside XWalk1?	N/A	N/A	Ramp inside XWalk2?	N/A
	Road Slope (%)	3.4	N/A	Clear Space?	Yes
	Road X Slope (%)	9.9	N/A	Clear Space to XWalk (in)	N/A
Yes	Any Obstructions?	No	Yes	Storm Grate/Utility Hazard?	No
	Obstruction Type			Storm Grate/Utility Type	
	N/A				N/A
			Yes	Surface Condition? (G/P)	Good

Remove & Replace Curb Ramp With Two New Directional Ramps or Equivalent. Remove & Replace Gutter.
