Access Compliance Report
Public Rights-of-Way
(Curb Ramps)

Intersection ID: 12144	Main Street: ALLEGHANY_ST	Cross Street: WILKINSON_BV	Location:	NE
ADA ID: 9714D5401CDC	Ramp Type: Perp	Initial Pass/Fail: Fail	Overall Compliance: No	Severity Score: 22.5

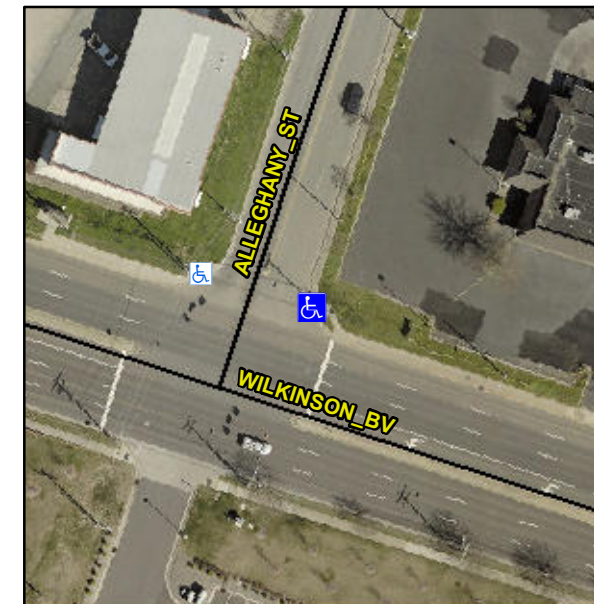
Not Found, R304.5.1, R304.2.2, R304.5.3

Compliance	Description	Data	Compliance	Description	Data
N/A	Ramp Length (in)	73.5	No	Ramp Slope (%)	10.0
No	Ramp Width (in)	47.0	No	Ramp XSlope (%)	4.9
N/A	Flare Type LT	N/A	N/A	Flare Type RT	N/A
N/A	Flare Slope LT (%)	N/A	N/A	Flare Slope RT (%)	N/A
N/A	Flare Traversable LT?	N/A	N/A	Flare Traversable RT?	N/A
N/A	Landing Length (in)	N/A	N/A	DWS Provided?	N/A
N/A	Landing Width (in)	N/A	N/A	DWS Contrast?	N/A
N/A	Landing Slope (%)	N/A	N/A	DWS Length (in)	N/A
N/A	Landing X Slope (%)	N/A	N/A	DWS Full Width?	N/A
N/A	Landing Curb? (Y/N)	N/A	N/A	DWS Offset (in)	N/A
N/A	Shared Landing?	N/A			
N/A	Gutter Ponding?	N/A	N/A	Gutter Slope (%)	N/A
N/A	Gutter Lip Ht (in)	N/A	N/A	Gutter X Slope (%)	N/A
N/A	Painted X Walk1?	No	N/A	Painted X Walk2?	N/A
	X Walk 1 Direction	To NW		X Walk 2 Direction	N/A
N/A	X Walk 1 Width (in)	N/A	N/A	X Walk 2 Width (in)	N/A
	X Walk 1 Slope (%)	2.5		X Walk 2 Slope (%)	N/A
	X Walk 1 X Slope (%)	9.4		X Walk 2 X Slope (%)	N/A

Remove & Replace Entire Ramp.
