Access Compliance Report
Public Rights-of-Way
(Curb Ramps)

Intersection ID: 32312	**Main Street: CAMBRIDGE_WOODS_CT**	**Cross Street: TRAVIS_GULCH_DR**	**Location: NW**
ADA ID: 972517AF39AC	**Ramp Type: Perp**	**Initial Pass/Fail: Fail**	**Overall Compliance: No** / **Severity Score: 13.75**

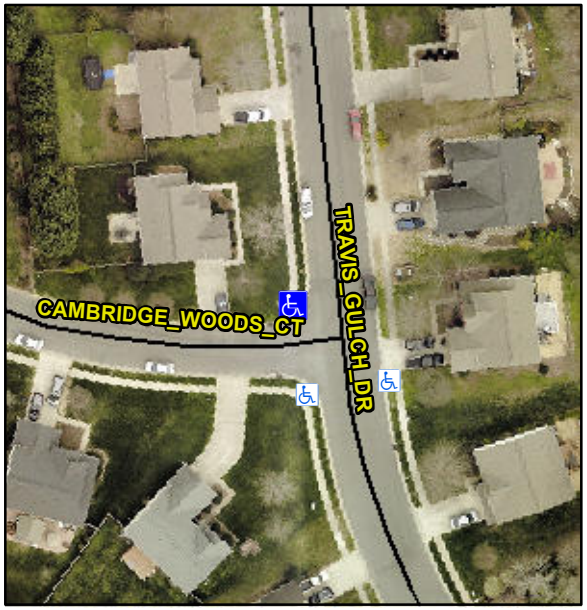
R304.2.2, R304.5.3

Compliance	Description	Data	Compliance	Description	Data
N/A	Ramp Length (in)	49.0	No	Ramp Slope (%)	8.9
Yes	Ramp Width (in)	48.0	No	Ramp XSlope (%)	3.1
N/A	Flare Type LT	N/A	N/A	Flare Type RT	N/A
N/A	Flare Slope LT (%)	N/A	N/A	Flare Slope RT (%)	N/A
N/A	Flare Traversable LT?	N/A	N/A	Flare Traversable RT?	N/A
N/A	Landing Length (in)	N/A	N/A	DWS Provided?	N/A
N/A	Landing Width (in)	N/A	N/A	DWS Contrast?	N/A
N/A	Landing Slope (%)	N/A	N/A	DWS Length (in)	N/A
N/A	Landing X Slope (%)	N/A	N/A	DWS Full Width?	N/A
N/A	Landing Curb? (Y/N)	N/A	N/A	DWS Offset (in)	N/A
N/A	Shared Landing?	N/A			
N/A	Gutter Ponding?	N/A	N/A	Gutter Slope (%)	N/A
N/A	Gutter Lip Ht (in)	N/A	N/A	Gutter X Slope (%)	N/A
N/A	Painted X Walk1?	No	N/A	Painted X Walk2?	N/A
	X Walk 1 Direction	To S		X Walk 2 Direction	N/A
N/A	X Walk 1 Width (in)	N/A	N/A	X Walk 2 Width (in)	N/A
	X Walk 1 Slope (%)	3.4		X Walk 2 Slope (%)	N/A
	X Walk 1 X Slope (%)	1.9		X Walk 2 X Slope (%)	N/A

Remove & Replace Entire Ramp.
