Access Compliance Report
Public Rights-of-Way
(Curb Ramps)

Intersection ID: 47819 | **Main Street:** JAMES_RD | **Cross Street:** ROCKMOOR_RIDGE_RD | **Location:** NW

ADA ID: 977EBA825C41 | **Ramp Type:** Perp | **Initial Pass/Fail:** Fail | **Overall Compliance:** No | **Severity Score:** 21.25

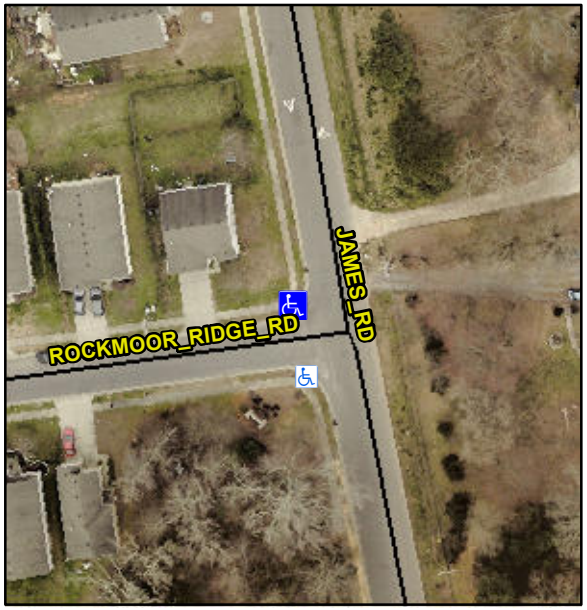
Not Found, R304.5.1, R304.2.2

Remove & Replace Entire Ramp.

Total Cost: $ 1850.00

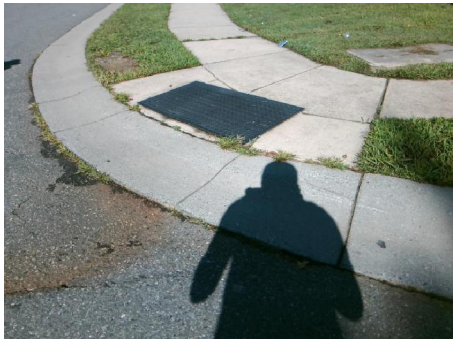
Compliance	Description	Data	Compliance	Description	Data
N/A	Ramp Length (in)	29.0	No	Ramp Slope (%)	10.1
No	Ramp Width (in)	47.0	Yes	Ramp XSlope (%)	0.2
N/A	Flare Type LT	N/A	N/A	Flare Type RT	N/A
N/A	Flare Slope LT (%)	N/A	N/A	Flare Slope RT (%)	N/A
N/A	Flare Traversable LT?	N/A	N/A	Flare Traversable RT?	N/A
N/A	Landing Length (in)	N/A	N/A	DWS Provided?	N/A
N/A	Landing Width (in)	N/A	N/A	DWS Contrast?	N/A
N/A	Landing Slope (%)	N/A	N/A	DWS Length (in)	N/A
N/A	Landing X Slope (%)	N/A	N/A	DWS Full Width?	N/A
N/A	Landing Curb? (Y/N)	N/A	N/A	DWS Offset (in)	N/A
N/A	Shared Landing?	N/A			
N/A	Gutter Ponding?	N/A	N/A	Gutter Slope (%)	N/A
N/A	Gutter Lip Ht (in)	1.0	N/A	Gutter X Slope (%)	N/A
N/A	Painted X Walk1?	No	N/A	Painted X Walk2?	N/A
	X Walk 1 Direction	To S		X Walk 2 Direction	N/A
N/A	X Walk 1 Width (in)	N/A	N/A	X Walk 2 Width (in)	N/A
	X Walk 1 Slope (%)	0.9		X Walk 2 Slope (%)	N/A

X Walk 1 X Slope (%)	2.9		X Walk 2 X Slope (%)	N/A
N/A	Ramp inside XWalk1?	N/A	N/A	Ramp inside XWalk2?	N/A
	Road Slope (%)	N/A	N/A	Clear Space?	N/A
	Road X Slope (%)	N/A	N/A	Clear Space to XWalk (in)	N/A
N/A	Any Obstructions?	N/A	N/A	Storm Grate/Utility Hazard?	N/A
	Obstruction Type			Storm Grate/Utility Type	
		N/A			N/A
			Yes	Surface Condition? (G/P)	Good
