# Access Compliance Report
Public Rights-of-Way
(Curb Ramps)

Intersection ID: 10023918 **Main Street:** CONFERENCE_DR **Cross Street:** N/A **Location:** SE

ADA ID: 98272CC068B8 **Ramp Type:** BlendTrans1 **Initial Pass/Fail:** Pass **Overall Compliance:** No **Severity Score:** 0.25

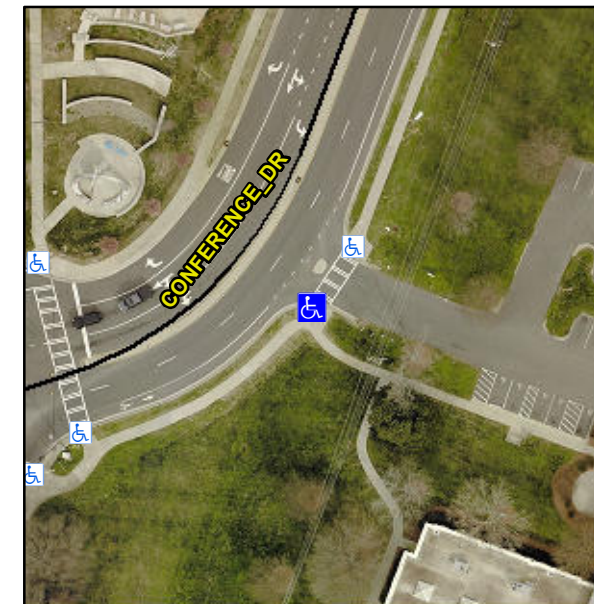
R304.5.3

Compliance	Description	Data	Compliance	Description	Data
N/A	Ramp Length (in)	91.0	Yes	BlendTrans Slope (%)	2.0
Yes	Ramp Width (in)	48.0	No	BlendTrans XSlope (%)	3.7
N/A	Flare Type LT	Sloped	N/A	Flare Type RT	Sloped
N/A	Flare Slope LT (%)	2.1	N/A	Flare Slope RT (%)	7.3
N/A	Flare Traversable LT?	No	N/A	Flare Traversable RT?	No
Yes	Landing Length (in)	65.0	Yes	DWS Provided?	Yes
Yes	Landing Width (in)	48.0	Yes	DWS Contrast?	Yes
Yes	Landing Slope (%)	1.1	Yes	DWS Length (in)	24.0
Yes	Landing X Slope (%)	0.9	Yes	DWS Full Width?	Yes
N/A	Landing Curb? (Y/N)	No	Yes	DWS Offset (in)	0.0
N/A	Shared Landing?	No			
Yes	Gutter Ponding?	No	Yes	Gutter Slope (%)	3.9
Yes	Gutter Lip Ht (in)	0.0	Yes	Gutter X Slope (%)	1.4
N/A	Painted X Walk1?	Yes	N/A	Painted X Walk2?	No
	X Walk 1 Direction	To NE		X Walk 2 Direction	To NW
	X Walk 1 Width (in)	110.0		X Walk 2 Width (in)	N/A
	X Walk 1 Slope (%)	1.6		X Walk 2 Slope (%)	0.3
	X Walk 1 X Slope (%)	1.1		X Walk 2 X Slope (%)	0.9

Yes	Ramp inside XWalk1?	Yes	N/A	Ramp inside XWalk2?	N/A
	Road Slope (%)	0.6	Yes	Clear Space?	Yes
	Road X Slope (%)	0.6	N/A	Clear Space to XWalk (in)	N/A
Yes	Any Obstructions?	No	Yes	Storm Grate/Utility Hazard?	No
	Obstruction Type			Storm Grate/Utility Type	
N/A					N/A
			Yes	Surface Condition? (G/P)	Good
			N/A	Curb Slope (%)	3.1

Remove & Replace Curb Ramp With Two New Directional Ramps or Equivalent.
