Access Compliance Report
Public Rights-of-Way
(Curb Ramps)

Intersection ID: 8652 **Main Street:** ERIE_ST **Cross Street:** HATERAS_AV **Location:** NE

ADA ID: 98CDF0BCDF10 **Ramp Type:** Perp **Initial Pass/Fail:** Fail **Overall Compliance:** No **Severity Score:** 10

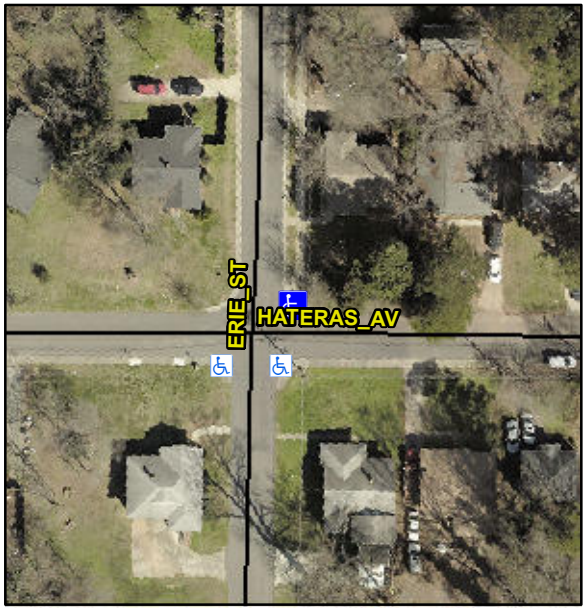
Not Found, R304.5.1

Compliance	Description	Data	Compliance	Description	Data
N/A	Ramp Length (in)	56.0	Yes	Ramp Slope (%)	5.4
No	Ramp Width (in)	47.5	Yes	Ramp XSlope (%)	4.7
N/A	Flare Type LT	N/A	N/A	Flare Type RT	N/A
N/A	Flare Slope LT (%)	N/A	N/A	Flare Slope RT (%)	N/A
N/A	Flare Traversable LT?	N/A	N/A	Flare Traversable RT?	N/A
N/A	Landing Length (in)	N/A	N/A	DWS Provided?	N/A
N/A	Landing Width (in)	N/A	N/A	DWS Contrast?	N/A
N/A	Landing Slope (%)	N/A	N/A	DWS Length (in)	N/A
N/A	Landing X Slope (%)	N/A	N/A	DWS Full Width?	N/A
N/A	Landing Curb? (Y/N)	N/A	N/A	DWS Offset (in)	N/A
N/A	Shared Landing?	N/A			
N/A	Gutter Ponding?	N/A	N/A	Gutter Slope (%)	N/A
N/A	Gutter Lip Ht (in)	N/A	N/A	Gutter X Slope (%)	N/A
N/A	Painted X Walk1?	No	N/A	Painted X Walk2?	N/A
	X Walk 1 Direction	To S		X Walk 2 Direction	N/A
N/A	X Walk 1 Width (in)	N/A	N/A	X Walk 2 Width (in)	N/A
	X Walk 1 Slope (%)	4.9		X Walk 2 Slope (%)	N/A
	X Walk 1 X Slope (%)	6.9		X Walk 2 X Slope (%)	N/A

Remove & Replace Entire Ramp.
