Access Compliance Report
Public Rights-of-Way
(Curb Ramps)

Intersection ID: 29992	**Main Street:** REIGATE_RD	**Cross Street:** KEMPSFORD_DR	**Location:** W
ADA ID: 990F6541D7D7	**Ramp Type:** PerpDiag	**Initial Pass/Fail:** Fail	**Overall Compliance:** No	**Severity Score:** 22.5

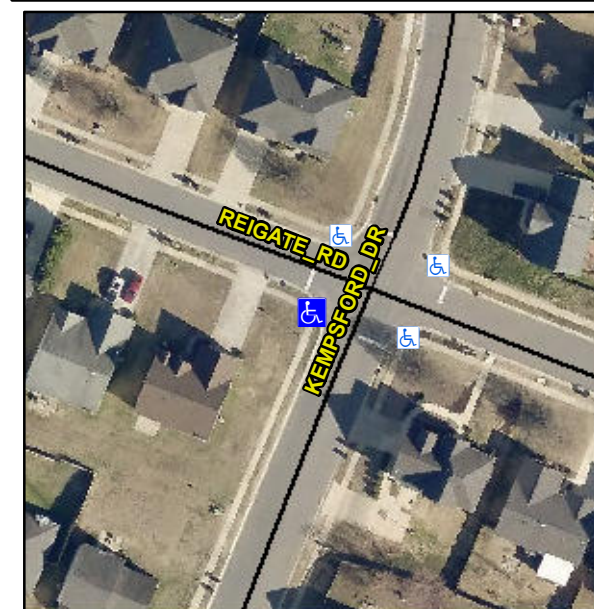
Not Found, R304.5.1, R304.2.2, R304.5.3

Compliance	Description	Data	Compliance	Description	Data
N/A	Ramp Length (in)	50.0	No	Ramp Slope (%)	10.5
No	Ramp Width (in)	43.0	No	Ramp XSlope (%)	3.7
N/A	Flare Type LT	N/A	N/A	Flare Type RT	N/A
N/A	Flare Slope LT (%)	N/A	N/A	Flare Slope RT (%)	N/A
N/A	Flare Traversable LT?	N/A	N/A	Flare Traversable RT?	N/A
N/A	Landing Length (in)	N/A	N/A	DWS Provided?	N/A
N/A	Landing Width (in)	N/A	N/A	DWS Contrast?	N/A
N/A	Landing Slope (%)	N/A	N/A	DWS Length (in)	N/A
N/A	Landing X Slope (%)	N/A	N/A	DWS Full Width?	N/A
N/A	Landing Curb? (Y/N)	N/A	N/A	DWS Offset (in)	N/A
N/A	Shared Landing?	N/A			
N/A	Gutter Ponding?	N/A	N/A	Gutter Slope (%)	N/A
N/A	Gutter Lip Ht (in)	N/A	N/A	Gutter X Slope (%)	N/A
N/A	Painted X Walk1?	No	N/A	Painted X Walk2?	No
	X Walk 1 Direction	To SE		X Walk 2 Direction	To NE
N/A	X Walk 1 Width (in)	N/A	N/A	X Walk 2 Width (in)	N/A
	X Walk 1 Slope (%)	2.8		X Walk 2 Slope (%)	1.9
	X Walk 1 X Slope (%)	2.0		X Walk 2 X Slope (%)	3.3

Remove & Replace Curb Ramp With Two New Directional Ramps or Equivalent.
