# Access Compliance Report
## Public Rights-of-Way
## (Curb Ramps)

| **Intersection ID:** 53537 | **Main Street:** MACFARLANE_BV | **Cross Street:** IKEA_BV | **Location:** N |
| **ADA ID:** 99EB0E8A2699 | **Ramp Type:** Perp | **Initial Pass/Fail:** Fail **Overall Compliance:** No | **Severity Score:** 10 |

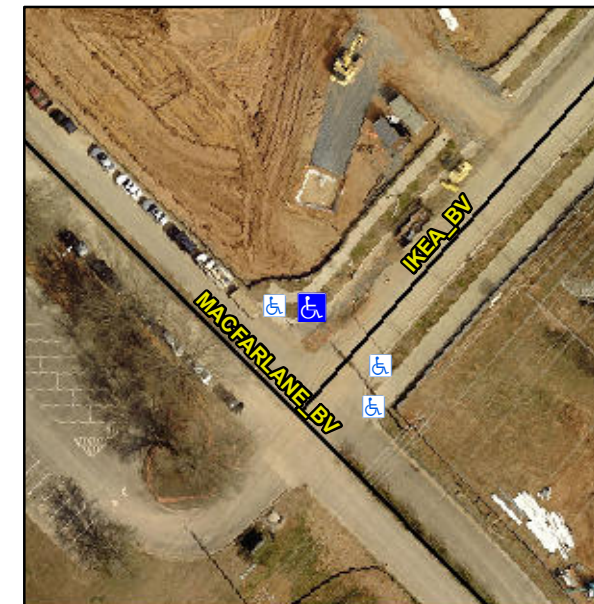
**Not Found, R304.5.1, R304.5.3**

| Compliance | Description | Data | Compliance | Description | Data |
|---|---|---|---|---|---|
| No | Ramp Width (in) | 46.0 | No | Ramp XSlope (%) | 3.7 |

**Remove & Replace Entire Ramp.**
