Access Compliance Report
Public Rights-of-Way
(Curb Ramps)

Intersection ID: 10018518 **Main Street:** DUMONT_LN **Cross Street:** N/A **Location:** N

ADA ID: 9A0DDC681E64 **Ramp Type:** BlendTrans1 **Initial Pass/Fail:** Fail **Overall Compliance:** No **Severity Score:** 12.5

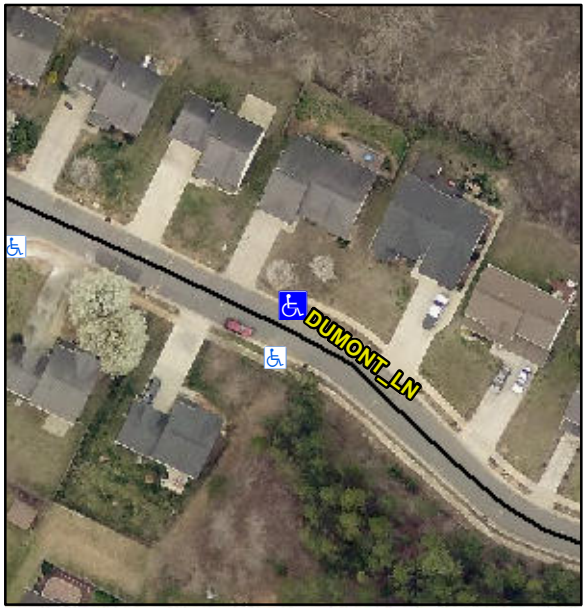
Not Found, R304.5.3

Compliance	Description	Data	Compliance	Description	Data
N/A	Ramp Length (in)	45.0	Yes	BlendTrans Slope (%)	4.7
Yes	Ramp Width (in)	50.0	No	BlendTrans XSlope (%)	5.4
N/A	Flare Type LT	N/A	N/A	Flare Type RT	N/A
N/A	Flare Slope LT (%)	N/A	N/A	Flare Slope RT (%)	N/A
N/A	Flare Traversable LT?	N/A	N/A	Flare Traversable RT?	N/A
N/A	Landing Length (in)	N/A	N/A	DWS Provided?	N/A
N/A	Landing Width (in)	N/A	N/A	DWS Contrast?	N/A
N/A	Landing Slope (%)	N/A	N/A	DWS Length (in)	N/A
N/A	Landing X Slope (%)	N/A	N/A	DWS Full Width?	N/A
N/A	Landing Curb? (Y/N)	N/A	N/A	DWS Offset (in)	N/A
N/A	Shared Landing?	N/A			
N/A	Gutter Ponding?	N/A	N/A	Gutter Slope (%)	N/A
N/A	Gutter Lip Ht (in)	N/A	N/A	Gutter X Slope (%)	N/A
N/A	Painted X Walk1?	No	N/A	Painted X Walk2?	N/A
	X Walk 1 Direction	To S		X Walk 2 Direction	N/A
	X Walk 1 Width (in)	N/A		X Walk 2 Width (in)	N/A
	X Walk 1 Slope (%)	6.2		X Walk 2 Slope (%)	N/A
	X Walk 1 X Slope (%)	2.2		X Walk 2 X Slope (%)	N/A

N/A	Ramp inside XWalk1?	N/A	N/A	Ramp inside XWalk2?	N/A
	Road Slope (%)	2.2		Clear Space?	N/A
	Road X Slope (%)	6.2	N/A	Clear Space to XWalk (in)	N/A
N/A	Any Obstructions?	N/A	N/A	Storm Grate/Utility Hazard?	N/A
	Obstruction Type			Storm Grate/Utility Type	
		N/A			N/A
			Yes	Surface Condition? (G/P)	Good
			No	Curb Slope (%)	7.1

Remove & Replace Curb Ramp With Two New Directional Ramps or Equivalent.
