Access Compliance Report
Public Rights-of-Way
(Curb Ramps)

Intersection ID: 10029688	**Main Street: KINGSLEY_VIEW_DR**	**Cross Street: N/A**	**Location: SE**
ADA ID: 9A61C6995065	**Ramp Type: PerpDiag**	**Initial Pass/Fail: Fail**	**Overall Compliance: No** **Severity Score: 25**

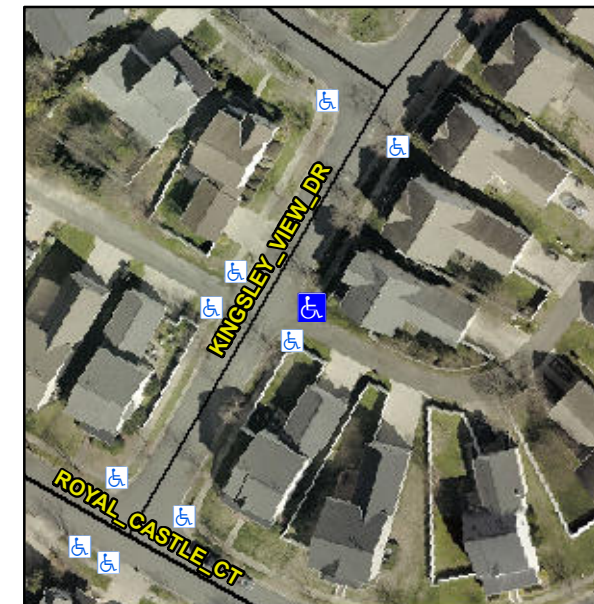
Compliance	Description	Data	Compliance	Description	Data
N/A	Ramp Length (in)	182.0	Yes	Ramp Slope (%)	12.2
Yes	Ramp Width (in)	48.0	Yes	Ramp XSlope (%)	0.4
N/A	Flare Type LT	N/A	N/A	Flare Type RT	N/A
N/A	Flare Slope LT (%)	N/A	N/A	Flare Slope RT (%)	N/A
N/A	Flare Traversable LT?	N/A	N/A	Flare Traversable RT?	N/A
N/A	Landing Length (in)	N/A	N/A	DWS Provided?	N/A
N/A	Landing Width (in)	N/A	N/A	DWS Contrast?	N/A
N/A	Landing Slope (%)	N/A	N/A	DWS Length (in)	N/A
N/A	Landing X Slope (%)	N/A	N/A	DWS Full Width?	N/A
N/A	Landing Curb? (Y/N)	N/A	N/A	DWS Offset (in)	N/A
N/A	Shared Landing?	N/A			
N/A	Gutter Ponding?	N/A	N/A	Gutter Slope (%)	N/A
N/A	Gutter Lip Ht (in)	N/A	N/A	Gutter X Slope (%)	N/A
N/A	Painted X Walk1?	No	N/A	Painted X Walk2?	No
	X Walk 1 Direction	To NW		X Walk 2 Direction	To SW
N/A	X Walk 1 Width (in)	N/A	N/A	X Walk 2 Width (in)	N/A
	X Walk 1 Slope (%)	3.1		X Walk 2 Slope (%)	7.8
	X Walk 1 X Slope (%)	3.5		X Walk 2 X Slope (%)	3.3

N/A	Ramp inside XWalk1?	N/A	N/A	Ramp inside XWalk2?	N/A
	Road Slope (%)	0.2	N/A	Clear Space?	N/A
	Road X Slope (%)	6.1	N/A	Clear Space to XWalk (in)	N/A
N/A	Any Obstructions?	N/A	N/A	Storm Grate/Utility Hazard?	N/A
	Obstruction Type			Storm Grate/Utility Type	
N/A					N/A
			Yes	Surface Condition? (G/P)	Good

Remove & Replace Curb Ramp With Two New Directional Ramps or Equivalent.
