Access Compliance Report
Public Rights-of-Way
(Curb Ramps)

Intersection ID: 10033067 **Main Street:** NORTH_COMMUNITY_HOUSE_RD **Cross Street:** N/A **Location:** E

ADA ID: 9B5804ED3E99 **Ramp Type:** Perp **Initial Pass/Fail:** Fail **Overall Compliance:** No **Severity Score:** 25

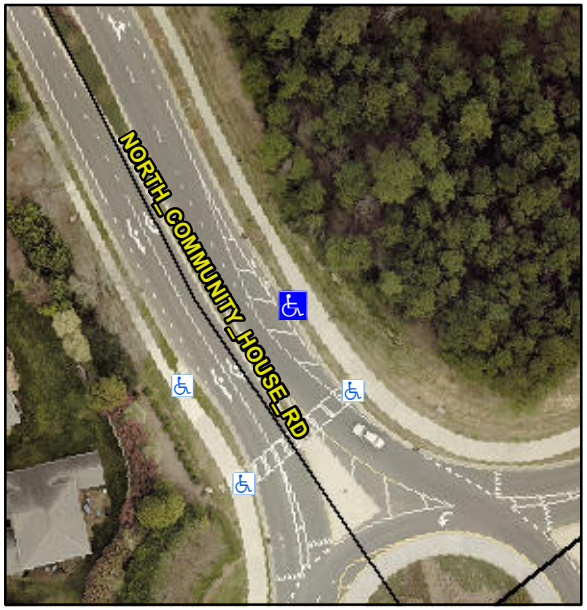
Not Found, R304.2.2

Compliance	Description	Data	Compliance	Description	Data
N/A	Ramp Length (in)	52.0	No	Ramp Slope (%)	14.2
Yes	Ramp Width (in)	94.0	Yes	Ramp XSlope (%)	1.6
N/A	Flare Type LT	N/A	N/A	Flare Type RT	N/A
N/A	Flare Slope LT (%)	N/A	N/A	Flare Slope RT (%)	N/A
N/A	Flare Traversable LT?	N/A	N/A	Flare Traversable RT?	N/A
N/A	Landing Length (in)	N/A	N/A	DWS Provided?	N/A
N/A	Landing Width (in)	N/A	N/A	DWS Contrast?	N/A
N/A	Landing Slope (%)	N/A	N/A	DWS Length (in)	N/A
N/A	Landing X Slope (%)	N/A	N/A	DWS Full Width?	N/A
N/A	Landing Curb? (Y/N)	N/A	N/A	DWS Offset (in)	N/A
N/A	Shared Landing?	N/A			
N/A	Gutter Ponding?	N/A	N/A	Gutter Slope (%)	N/A
N/A	Gutter Lip Ht (in)	N/A	N/A	Gutter X Slope (%)	N/A
N/A	Painted X Walk1?	No	N/A	Painted X Walk2?	N/A
	X Walk 1 Direction	To SW		X Walk 2 Direction	N/A
N/A	X Walk 1 Width (in)	N/A	N/A	X Walk 2 Width (in)	N/A
	X Walk 1 Slope (%)	1.9		X Walk 2 Slope (%)	N/A
	X Walk 1 X Slope (%)	1.5		X Walk 2 X Slope (%)	N/A

Remove & Replace Entire Ramp.
