Access Compliance Report
Public Rights-of-Way
(Curb Ramps)

Intersection ID: N/A	Main Street: YORK_CENTER	Cross Street: N/A	Location:	NW

ADA ID: 9C0ECE65E4BE	Ramp Type: Perp	Initial Pass/Fail: Fail	Overall Compliance: No	Severity Score: 33.75

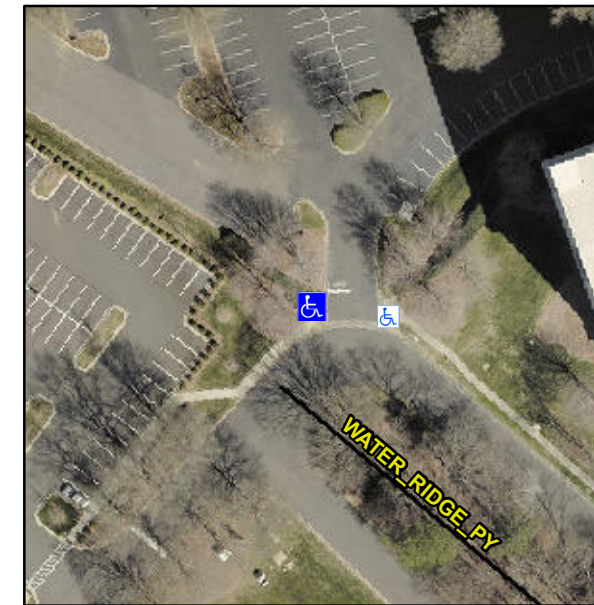
Not Found, R304.5.1, R304.5.3

Compliance	Description	Data	Compliance	Description	Data
N/A	Ramp Length (in)	60.0	Yes	Ramp Slope (%)	6.3
No	Ramp Width (in)	43.0	No	Ramp XSlope (%)	8.3
N/A	Flare Type LT	N/A	N/A	Flare Type RT	N/A
N/A	Flare Slope LT (%)	N/A	N/A	Flare Slope RT (%)	N/A
N/A	Flare Traversable LT?	N/A	N/A	Flare Traversable RT?	N/A
N/A	Landing Length (in)	N/A	N/A	DWS Provided?	N/A
N/A	Landing Width (in)	N/A	N/A	DWS Contrast?	N/A
N/A	Landing Slope (%)	N/A	N/A	DWS Length (in)	N/A
N/A	Landing X Slope (%)	N/A	N/A	DWS Full Width?	N/A
N/A	Landing Curb? (Y/N)	N/A	N/A	DWS Offset (in)	N/A
N/A	Shared Landing?	N/A			
N/A	Gutter Ponding?	N/A	N/A	Gutter Slope (%)	N/A
N/A	Gutter Lip Ht (in)	N/A	N/A	Gutter X Slope (%)	N/A
N/A	Painted X Walk1?	No	N/A	Painted X Walk2?	N/A
	X Walk 1 Direction	To E		X Walk 2 Direction	N/A
N/A	X Walk 1 Width (in)	N/A	N/A	X Walk 2 Width (in)	N/A
	X Walk 1 Slope (%)	1.8		X Walk 2 Slope (%)	N/A
	X Walk 1 X Slope (%)	10.5		X Walk 2 X Slope (%)	N/A

Remove & Replace Entire Ramp.
