Access Compliance Report
Public Rights-of-Way
(Curb Ramps)

Intersection ID: 16042 **Main Street:** POINDEXTER_DR **Cross Street:** SUNSET_DR **Location:** S

ADA ID: 9C322A21413A **Ramp Type:** Directional1 **Initial Pass/Fail:** Fail **Overall Compliance:** No **Severity Score:** 1.25

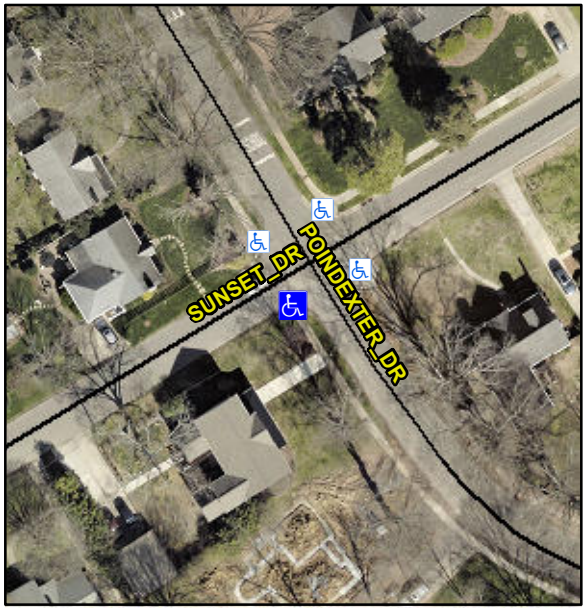
DAMAGED NO CURB, LNDG LIP 2.0", WTR VAL LNDG LIP 1.5"

R304.5.3

Compliance	Description	Data	Compliance	Description	Data
N/A	Ramp Length (in)	77.0	N/A	Grade Break?	N/A
Yes	Ramp Width (in)	48.0	N/A	Grade Break Slope (%)	0.0
Yes	Ramp Slope (%)	6.1	N/A	Grade Break XSlope (%)	0.0
No	Ramp XSlope (%)	4.8			
N/A	Flare Type LT	N/A	N/A	Flare Type RT	N/A
N/A	Flare Slope LT (%)	N/A	N/A	Flare Slope RT (%)	0.0
N/A	Flare Traversable LT?	N/A	N/A	Flare Traversable RT?	N/A
N/A	Landing Length (in)	0.0	N/A	DWS Provided?	N/A
N/A	Landing Width (in)	0.0	N/A	DWS Contrast?	N/A
N/A	Landing Slope (%)	0.0	N/A	DWS Length (in)	N/A
N/A	Landing X Slope (%)	0.0	N/A	DWS Full Width?	N/A
N/A	Landing Curb? (Y/N)	N/A	N/A	DWS Offset LT (in)	N/A
N/A	Shared Landing?	N/A	N/A	DWS Offset RT (in)	N/A
N/A	Gutter Ponding?	0.0	N/A	Gutter Slope (%)	N/A
N/A	Gutter Lip Ht (in)	0.0	N/A	Gutter X Slope (%)	N/A
N/A	Painted X Walk1?	No		Road Slope (%)	4.1
	X Walk 1 Direction	To NW		Road X Slope (%)	1.4
	X Walk 1 Width (in)	N/A		Clear Space?	N/A

Remove & Replace Entire Ramp.
