# Access Compliance Report
Public Rights-of-Way
(Curb Ramps)

Intersection ID: 42988   **Main Street: UNIVERSITY_CITY_BV**   **Cross Street: N/A**   **Location: S**

ADA ID: 9C4BD463DAEE   **Ramp Type: Para**   **Initial Pass/Fail: Fail**   **Overall Compliance: No**   **Severity Score: 12.5**

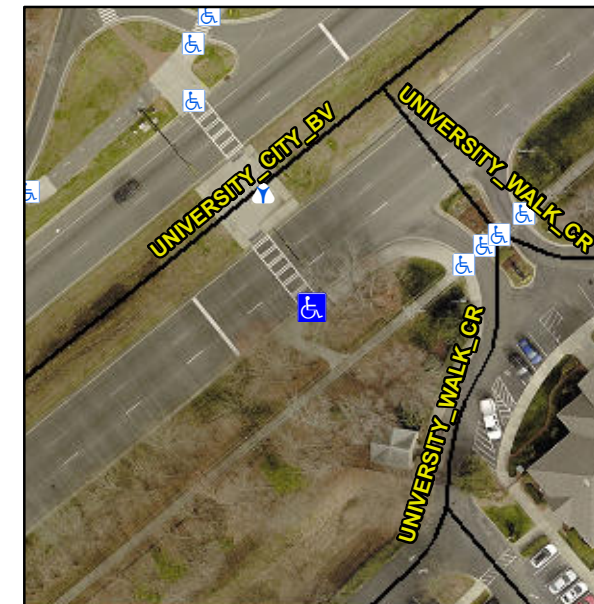
Compliance	Description	Data	Compliance	Description	Data
N/A	Ramp Length LT (in)	82.0	N/A	Ramp Length RT (in)	71.0
Yes	Ramp Width LT (in)	88.0	Yes	Ramp Width RT (in)	66.0
Yes	Ramp Slope LT (%)	4.4	No	Ramp Slope RT (%)	8.5
Yes	Ramp XSlope LT (%)	0.6	Yes	Ramp XSlope RT (%)	1.7
N/A	Landing Length (in)	N/A	N/A	DWS Provided?	N/A
N/A	Landing Width (in)	N/A	N/A	DWS Contrast?	N/A
N/A	Landing Slope (%)	N/A	N/A	DWS Length (in)	N/A
N/A	Landing X Slope (%)	N/A	N/A	DWS Full Width?	N/A
N/A	Landing Curb? (Y/N)	N/A	N/A	DWS Offset (in)	N/A
N/A	Shared Landing?	N/A			
N/A	Gutter Ponding?	N/A	N/A	Gutter Slope (%)	N/A
N/A	Gutter Lip Ht (in)	N/A	N/A	Gutter X Slope (%)	N/A
N/A	Painted X Walk1?	Yes	N/A	Painted X Walk2?	N/A
	X Walk 1 Direction	To NW		X Walk 2 Direction	N/A
N/A	X Walk 1 Width (in)	112.0	N/A	X Walk 2 Width (in)	N/A
	X Walk 1 Slope (%)	4.2		X Walk 2 Slope (%)	N/A
	X Walk 1 X Slope (%)	0.6		X Walk 2 X Slope (%)	N/A
N/A	Ramp inside XWalk1?	Yes	N/A	Ramp inside XWalk2?	N/A

LT RP < 5%

R304.3.2

Remove & Replace Entire Ramp.
