Access Compliance Report
Public Rights-of-Way
(Curb Ramps)

Intersection ID: N/A | **Main Street:** ALLEGIANCE DR | **Cross Street:** LADY LIBERTY LN | **Location:** NE

ADA ID: 9D111B141C00 | **Ramp Type:** BlendTrans1 | **Initial Pass/Fail:** Fail | **Overall Compliance:** No | **Severity Score:** 33.75

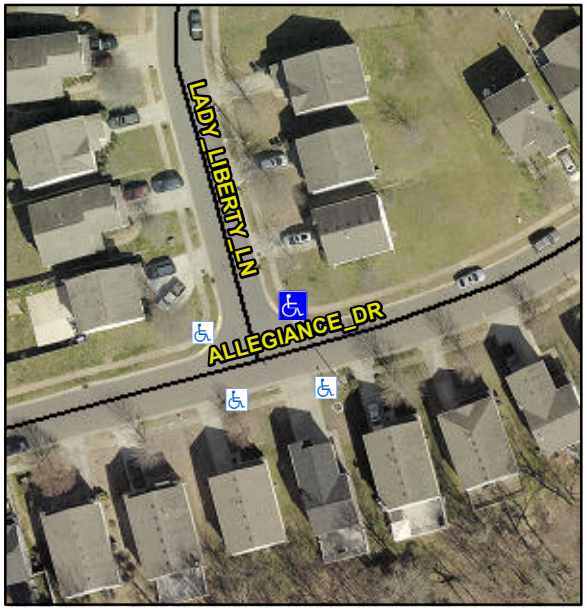
R304.5.1, R304.5.3

Compliance	Description	Data	Compliance	Description	Data
N/A	Ramp Length (in)	49.0	Yes	BlendTrans Slope (%)	4.7
No	Ramp Width (in)	43.0	No	BlendTrans XSlope (%)	8.4
N/A	Flare Type LT	N/A	N/A	Flare Type RT	N/A
N/A	Flare Slope LT (%)	N/A	N/A	Flare Slope RT (%)	N/A
N/A	Flare Traversable LT?	No	N/A	Flare Traversable RT?	No
N/A	Landing Length (in)	N/A	N/A	DWS Provided?	N/A
N/A	Landing Width (in)	N/A	N/A	DWS Contrast?	N/A
N/A	Landing Slope (%)	N/A	N/A	DWS Length (in)	N/A
N/A	Landing X Slope (%)	N/A	N/A	DWS Full Width?	N/A
N/A	Landing Curb? (Y/N)	N/A	N/A	DWS Offset (in)	N/A
N/A	Shared Landing?	N/A			
N/A	Gutter Ponding?	N/A	N/A	Gutter Slope (%)	N/A
N/A	Gutter Lip Ht (in)	N/A	N/A	Gutter X Slope (%)	N/A
N/A	Painted X Walk1?	No	N/A	Painted X Walk2?	No
	X Walk 1 Direction	To W		X Walk 2 Direction	To S
	X Walk 1 Width (in)	N/A		X Walk 2 Width (in)	N/A
	X Walk 1 Slope (%)	2.7		X Walk 2 Slope (%)	1.4
	X Walk 1 X Slope (%)	2.7		X Walk 2 X Slope (%)	4.1

N/A	Ramp inside XWalk1?	N/A	N/A	Ramp inside XWalk2?	No
	Road Slope (%)	4.4		Clear Space?	N/A
	Road X Slope (%)	1.4	N/A	Clear Space to XWalk (in)	N/A
N/A	Any Obstructions?	N/A	N/A	Storm Grate/Utility Hazard?	N/A
	Obstruction Type			Storm Grate/Utility Type	
		N/A			N/A
			Yes	Surface Condition? (G/P)	Good
			N/A	Curb Slope (%)	0.4

Remove & Replace Curb Ramp With Two New Directional Ramps or Equivalent.
