Access Compliance Report
Public Rights-of-Way
(Curb Ramps)

|			
Intersection ID: 3150	Main Street: OLD_TIMBER_RD	Cross Street: PROSPERITY_CHURCH_RD	Location: SW
ADA ID: 9E827CE84380	Ramp Type: Para	Initial Pass/Fail: Fail	Overall Compliance: No	Severity Score: 12.5

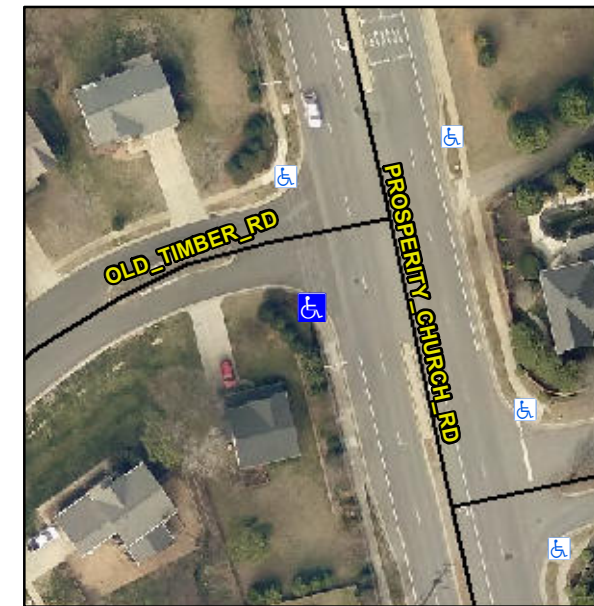
RT RP < 5%

R304.3.2

Compliance	Description	Data	Compliance	Description	Data
N/A	Ramp Length LT (in)	55.5	N/A	Ramp Length RT (in)	54.0
Yes	Ramp Width LT (in)	72.5	Yes	Ramp Width RT (in)	73.5
No	Ramp Slope LT (%)	10.3	Yes	Ramp Slope RT (%)	0.5
Yes	Ramp XSlope LT (%)	0.2	Yes	Ramp XSlope RT (%)	0.7
N/A	Landing Length (in)	N/A	N/A	DWS Provided?	N/A
N/A	Landing Width (in)	N/A	N/A	DWS Contrast?	N/A
N/A	Landing Slope (%)	N/A	N/A	DWS Length (in)	N/A
N/A	Landing X Slope (%)	N/A	N/A	DWS Full Width?	N/A
N/A	Landing Curb? (Y/N)	N/A	N/A	DWS Offset (in)	N/A
N/A	Shared Landing?	N/A			
N/A	Gutter Ponding?	N/A	N/A	Gutter Slope (%)	N/A
N/A	Gutter Lip Ht (in)	N/A	N/A	Gutter X Slope (%)	N/A
N/A	Painted X Walk1?	No	N/A	Painted X Walk2?	N/A
	X Walk 1 Direction	To N		X Walk 2 Direction	N/A
N/A	X Walk 1 Width (in)	N/A	N/A	X Walk 2 Width (in)	N/A
	X Walk 1 Slope (%)	0.9		X Walk 2 Slope (%)	N/A
	X Walk 1 X Slope (%)	11.0		X Walk 2 X Slope (%)	N/A
N/A	Ramp inside XWalk1?	N/A	N/A	Ramp inside XWalk2?	N/A

Remove & Replace Entire Ramp.
