Access Compliance Report
Public Rights-of-Way
(Curb Ramps)

Intersection ID: 27236	Main Street: BALLANTYNE_CORPORATE_PL	Cross Street: BRIXHAM_HILL_AV	Location:	SW
ADA ID: 9E8460C2C811	Ramp Type: Perp	Initial Pass/Fail: Fail	Overall Compliance: No	Severity Score: 13.75

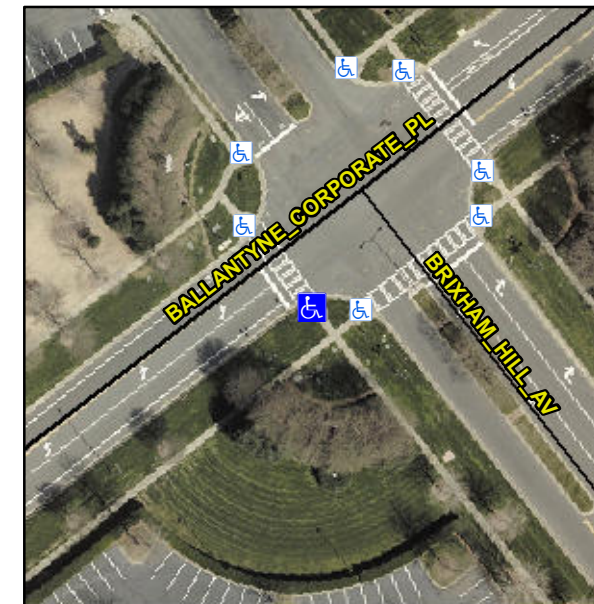
R304.2.2, R304.5.3

Compliance	Description	Data	Compliance	Description	Data
N/A	Ramp Length (in)	93.0	No	Ramp Slope (%)	11.7
Yes	Ramp Width (in)	48.0	No	Ramp XSlope (%)	2.6
N/A	Flare Type LT	N/A	N/A	Flare Type RT	N/A
N/A	Flare Slope LT (%)	N/A	N/A	Flare Slope RT (%)	N/A
N/A	Flare Traversable LT?	N/A	N/A	Flare Traversable RT?	N/A
N/A	Landing Length (in)	N/A	N/A	DWS Provided?	N/A
N/A	Landing Width (in)	N/A	N/A	DWS Contrast?	N/A
N/A	Landing Slope (%)	N/A	N/A	DWS Length (in)	N/A
N/A	Landing X Slope (%)	N/A	N/A	DWS Full Width?	N/A
N/A	Landing Curb? (Y/N)	N/A	N/A	DWS Offset (in)	N/A
N/A	Shared Landing?	N/A			
N/A	Gutter Ponding?	N/A	N/A	Gutter Slope (%)	N/A
N/A	Gutter Lip Ht (in)	N/A	N/A	Gutter X Slope (%)	N/A
N/A	Painted X Walk1?	Yes	N/A	Painted X Walk2?	N/A
	X Walk 1 Direction	To NW		X Walk 2 Direction	N/A
N/A	X Walk 1 Width (in)	110.0	N/A	X Walk 2 Width (in)	N/A
	X Walk 1 Slope (%)	3.6		X Walk 2 Slope (%)	N/A
	X Walk 1 X Slope (%)	0.5		X Walk 2 X Slope (%)	N/A

Remove & Replace Entire Ramp.
