Access Compliance Report
Public Rights-of-Way
(Curb Ramps)

Intersection ID: 46496 **Main Street:** BERE_ISLAND_DR **Cross Street:** TRAILWATER RD **Location:** S

ADA ID: 9F0FD5BE5E4F **Ramp Type:** PerpDiag **Initial Pass/Fail:** Fail **Overall Compliance:** No **Severity Score:** 21.25

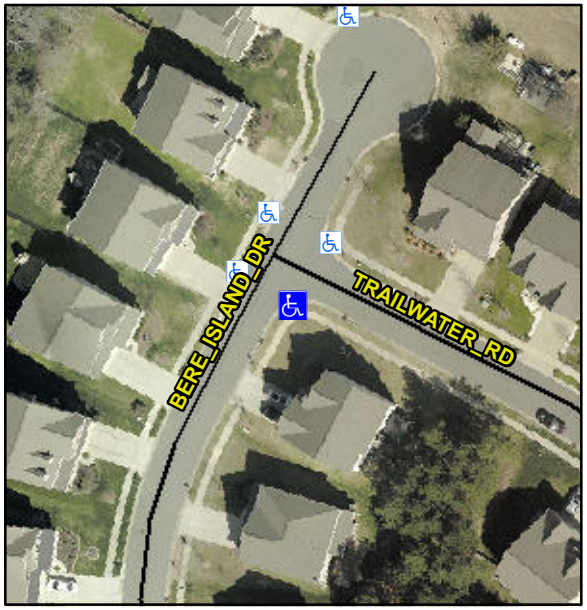
Not Found, R304.5.1, R304.2.2

Compliance	Description	Data	Compliance	Description	Data
N/A	Ramp Length (in)	47.0	No	Ramp Slope (%)	9.3
No	Ramp Width (in)	46.0	Yes	Ramp XSlope (%)	0.0
N/A	Flare Type LT	N/A	N/A	Flare Type RT	N/A
N/A	Flare Slope LT (%)	N/A	N/A	Flare Slope RT (%)	N/A
N/A	Flare Traversable LT?	N/A	N/A	Flare Traversable RT?	N/A
N/A	Landing Length (in)	N/A	N/A	DWS Provided?	N/A
N/A	Landing Width (in)	N/A	N/A	DWS Contrast?	N/A
N/A	Landing Slope (%)	N/A	N/A	DWS Length (in)	N/A
N/A	Landing X Slope (%)	N/A	N/A	DWS Full Width?	N/A
N/A	Landing Curb? (Y/N)	N/A	N/A	DWS Offset (in)	N/A
N/A	Shared Landing?	N/A			
N/A	Gutter Ponding?	N/A	N/A	Gutter Slope (%)	N/A
N/A	Gutter Lip Ht (in)	N/A	N/A	Gutter X Slope (%)	N/A
N/A	Painted X Walk1?	No	N/A	Painted X Walk2?	No
	X Walk 1 Direction	To NE		X Walk 2 Direction	To NW
N/A	X Walk 1 Width (in)	N/A	N/A	X Walk 2 Width (in)	N/A
	X Walk 1 Slope (%)	1.2		X Walk 2 Slope (%)	1.2
	X Walk 1 X Slope (%)	2.2		X Walk 2 X Slope (%)	2.2

Remove & Replace Curb Ramp With Two New Directional Ramps or Equivalent.
