Access Compliance Report
Public Rights-of-Way
(Curb Ramps)

Intersection ID: 19928	**Main Street:** BARCLAY_DOWNS_DR	**Cross Street:** CARNEGIE_BV	**Location:** SE
ADA ID: 9F24694B70CF	**Ramp Type:** PerpDiag	**Initial Pass/Fail:** Fail	**Overall Compliance:** No	**Severity Score:** 26.25

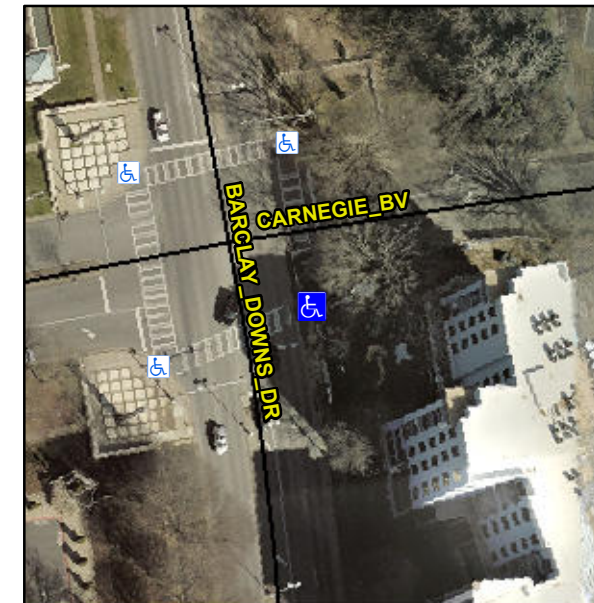
R304.2.2, R304.5.3

Compliance	Description	Data	Compliance	Description	Data
N/A	Ramp Length (in)	59.0	No	Ramp Slope (%)	13.3
Yes	Ramp Width (in)	50.0	No	Ramp XSlope (%)	2.5
N/A	Flare Type LT	N/A	N/A	Flare Type RT	N/A
N/A	Flare Slope LT (%)	N/A	N/A	Flare Slope RT (%)	N/A
N/A	Flare Traversable LT?	N/A	N/A	Flare Traversable RT?	N/A
N/A	Landing Length (in)	N/A	N/A	DWS Provided?	N/A
N/A	Landing Width (in)	N/A	N/A	DWS Contrast?	N/A
N/A	Landing Slope (%)	N/A	N/A	DWS Length (in)	N/A
N/A	Landing X Slope (%)	N/A	N/A	DWS Full Width?	N/A
N/A	Landing Curb? (Y/N)	N/A	N/A	DWS Offset (in)	N/A
N/A	Shared Landing?	N/A			
N/A	Gutter Ponding?	N/A	N/A	Gutter Slope (%)	N/A
N/A	Gutter Lip Ht (in)	N/A	N/A	Gutter X Slope (%)	N/A
N/A	Painted X Walk1?	Yes	N/A	Painted X Walk2?	Yes
	X Walk 1 Direction	To N		X Walk 2 Direction	To SW
N/A	X Walk 1 Width (in)	107.0	N/A	X Walk 2 Width (in)	125.0
	X Walk 1 Slope (%)	2.3		X Walk 2 Slope (%)	0.7
	X Walk 1 X Slope (%)	0.3		X Walk 2 X Slope (%)	0.9

Remove & Replace Curb Ramp With Two New Directional Ramps or Equivalent.
