Access Compliance Report
Public Rights-of-Way
(Curb Ramps)

Intersection ID: 14673	Main Street: BRIGHTON_PL	Cross Street: WOODLAND_DR	Location: SE
ADA ID: 9F6D4AB228CC	Ramp Type: BlendTrans2	Initial Pass/Fail: Fail Overall Compliance: No	Severity Score: 10

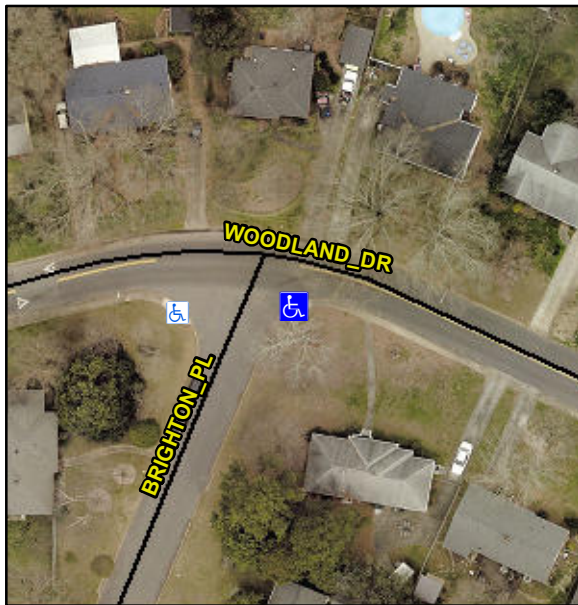
NO RT SW

R304.5.1, R304.5.3

Compliance	Description	Data	Compliance	Description	Data
N/A	Ramp Length (in)	68.0	Yes	BlendTrans Slope (%)	0.6
No	Ramp Width (in)	47.0	No	BlendTrans XSlope (%)	2.1
N/A	Flare Type LT	N/A	N/A	Flare Type RT	N/A
N/A	Flare Slope LT (%)	N/A	N/A	Flare Slope RT (%)	N/A
N/A	Flare Traversable LT?	N/A	N/A	Flare Traversable RT?	N/A
N/A	Landing Length (in)	N/A	N/A	DWS Provided?	N/A
N/A	Landing Width (in)	N/A	N/A	DWS Contrast?	N/A
N/A	Landing Slope (%)	N/A	N/A	DWS Length (in)	N/A
N/A	Landing X Slope (%)	N/A	N/A	DWS Full Width?	N/A
N/A	Landing Curb? (Y/N)	N/A	N/A	DWS Offset (in)	N/A
N/A	Shared Landing?	N/A			
N/A	Gutter Ponding?	Yes	N/A	Gutter Slope (%)	N/A
N/A	Gutter Lip Ht (in)	N/A	N/A	Gutter X Slope (%)	N/A
N/A	Painted X Walk1?	No	N/A	Painted X Walk2?	N/A
	X Walk 1 Direction	To W		X Walk 2 Direction	N/A
	X Walk 1 Width (in)	N/A		X Walk 2 Width (in)	N/A
	X Walk 1 Slope (%)	0.7		X Walk 2 Slope (%)	N/A
	X Walk 1 X Slope (%)	3.1		X Walk 2 X Slope (%)	N/A

Remove & Replace Curb Ramp With Two New Directional Ramps or Equivalent.
