Access Compliance Report
Public Rights-of-Way
(Curb Ramps)

Intersection ID: 10023160 **Main Street:** CHARLOTTE_VIEW_DR **Cross Street:** N/A **Location:** N

ADA ID: A08D4FAE6D80 **Ramp Type:** PerpDiag **Initial Pass/Fail:** Fail **Overall Compliance:** No **Severity Score:** 37.5

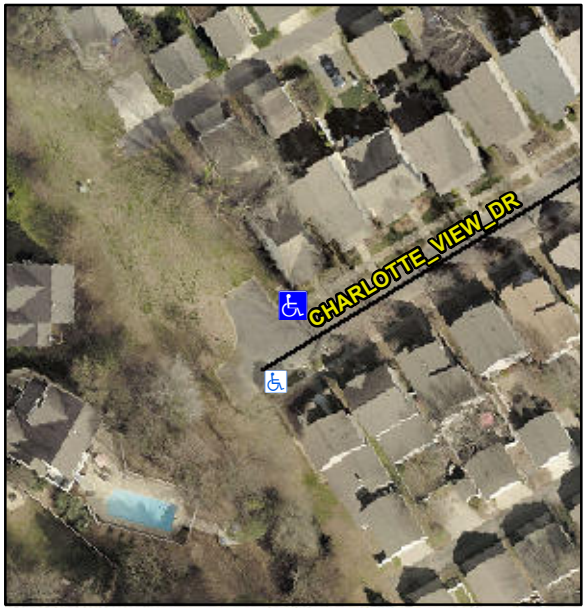
R304.2.2, R304.5.3

Compliance	Description	Data	Compliance	Description	Data
N/A	Ramp Length (in)	60.0	No	Ramp Slope (%)	17.1
Yes	Ramp Width (in)	48.0	No	Ramp XSlope (%)	5.5
N/A	Flare Type LT	N/A	N/A	Flare Type RT	N/A
N/A	Flare Slope LT (%)	N/A	N/A	Flare Slope RT (%)	N/A
N/A	Flare Traversable LT?	N/A	N/A	Flare Traversable RT?	N/A
N/A	Landing Length (in)	N/A	N/A	DWS Provided?	N/A
N/A	Landing Width (in)	N/A	N/A	DWS Contrast?	N/A
N/A	Landing Slope (%)	N/A	N/A	DWS Length (in)	N/A
N/A	Landing X Slope (%)	N/A	N/A	DWS Full Width?	N/A
N/A	Landing Curb? (Y/N)	N/A	N/A	DWS Offset (in)	N/A
N/A	Shared Landing?	N/A			
N/A	Gutter Ponding?	N/A	N/A	Gutter Slope (%)	N/A
N/A	Gutter Lip Ht (in)	N/A	N/A	Gutter X Slope (%)	N/A
N/A	Painted X Walk1?	No	N/A	Painted X Walk2?	No
	X Walk 1 Direction	To W		X Walk 2 Direction	To S
N/A	X Walk 1 Width (in)	N/A	N/A	X Walk 2 Width (in)	N/A
	X Walk 1 Slope (%)	2.6		X Walk 2 Slope (%)	7.9
	X Walk 1 X Slope (%)	5.6		X Walk 2 X Slope (%)	1.3

Remove & Replace Curb Ramp With Two New Directional Ramps or Equivalent.
