Access Compliance Report
Public Rights-of-Way
(Curb Ramps)

Intersection ID: 44781	Main Street: SILVER_CRESCENT_DR	Cross Street: TOMLIN_WAY_CT	Location: S
ADA ID: A09F8527AE9E	Ramp Type: PerpDiag	Initial Pass/Fail: Fail	Overall Compliance: No Severity Score: 12.5

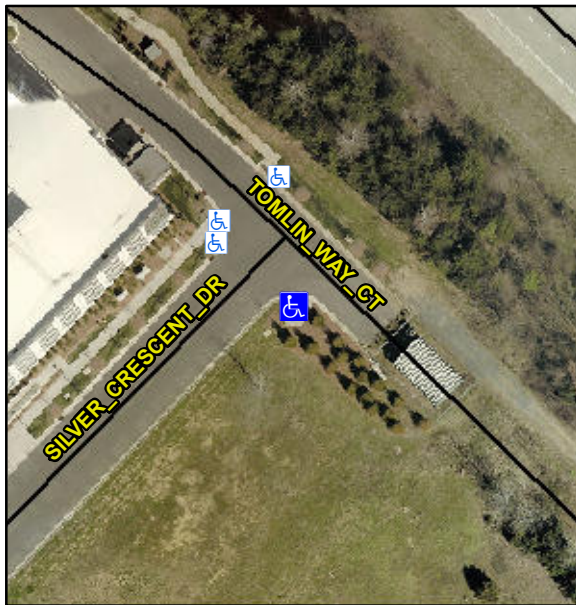
Compliance	Description	Data	Compliance	Description	Data
N/A	Ramp Length (in)	103.0	No	Ramp Slope (%)	8.5
Yes	Ramp Width (in)	60.0	Yes	Ramp XSlope (%)	1.4
N/A	Flare Type LT	N/A	N/A	Flare Type RT	N/A
N/A	Flare Slope LT (%)	N/A	N/A	Flare Slope RT (%)	N/A
N/A	Flare Traversable LT?	N/A	N/A	Flare Traversable RT?	N/A
N/A	Landing Length (in)	N/A	N/A	DWS Provided?	N/A
N/A	Landing Width (in)	N/A	N/A	DWS Contrast?	N/A
N/A	Landing Slope (%)	N/A	N/A	DWS Length (in)	N/A
N/A	Landing X Slope (%)	N/A	N/A	DWS Full Width?	N/A
N/A	Landing Curb? (Y/N)	N/A	N/A	DWS Offset (in)	N/A
N/A	Shared Landing?	N/A			
N/A	Gutter Ponding?	N/A	N/A	Gutter Slope (%)	N/A
N/A	Gutter Lip Ht (in)	N/A	N/A	Gutter X Slope (%)	N/A
N/A	Painted X Walk1?	No	N/A	Painted X Walk2?	No
	X Walk 1 Direction	To NE		X Walk 2 Direction	To NW
N/A	X Walk 1 Width (in)	N/A	N/A	X Walk 2 Width (in)	N/A
	X Walk 1 Slope (%)	4.8		X Walk 2 Slope (%)	4.3
	X Walk 1 X Slope (%)	3.7		X Walk 2 X Slope (%)	4.2

N/A	Ramp inside XWalk1?	N/A	N/A	Ramp inside XWalk2?	N/A
	Road Slope (%)	2.1	N/A	Clear Space?	N/A
	Road X Slope (%)	4.2	N/A	Clear Space to XWalk (in)	N/A
N/A	Any Obstructions?	N/A	N/A	Storm Grate/Utility Hazard?	N/A
	Obstruction Type			Storm Grate/Utility Type	
N/A					N/A
			Yes	Surface Condition? (G/P)	Good

Remove & Replace Curb Ramp With Two New Directional Ramps or Equivalent.
