Access Compliance Report
Public Rights-of-Way
(Curb Ramps)

Intersection ID: 10034400	**Main Street: PIEDMONT_PARK_DR**	**Cross Street: AUDUBON_PARK_DR**	**Location: W**
ADA ID: A0B862937647	**Ramp Type: Directional1**	**Initial Pass/Fail: Fail**	**Overall Compliance: No** / **Severity Score: 1.25**

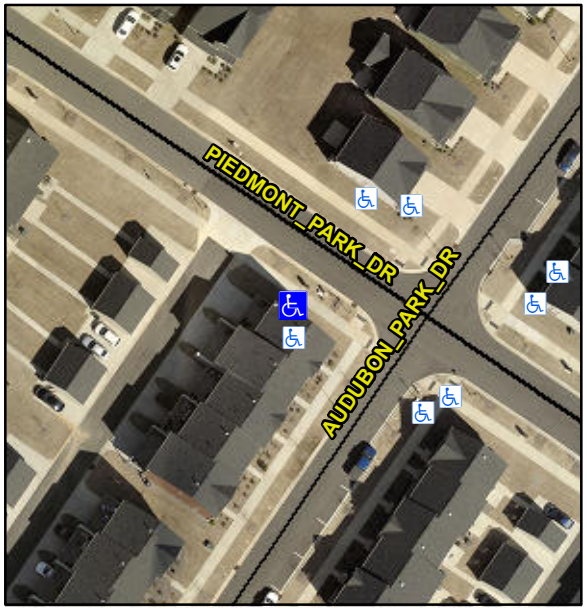
R304.5.3

Compliance	Description	Data	Compliance	Description	Data
N/A	Ramp Length (in)	77.0	N/A	Grade Break?	N/A
Yes	Ramp Width (in)	73.0	N/A	Grade Break Slope (%)	0.0
Yes	Ramp Slope (%)	1.7	N/A	Grade Break XSlope (%)	0.0
No	Ramp XSlope (%)	2.4			
N/A	Flare Type LT	N/A	N/A	Flare Type RT	N/A
N/A	Flare Slope LT (%)	N/A	N/A	Flare Slope RT (%)	0.0
N/A	Flare Traversable LT?	N/A	N/A	Flare Traversable RT?	N/A
N/A	Landing Length (in)	0.0	N/A	DWS Provided?	N/A
N/A	Landing Width (in)	0.0	N/A	DWS Contrast?	N/A
N/A	Landing Slope (%)	0.0	N/A	DWS Length (in)	N/A
N/A	Landing X Slope (%)	0.0	N/A	DWS Full Width?	N/A
N/A	Landing Curb? (Y/N)	N/A	N/A	DWS Offset LT (in)	N/A
N/A	Shared Landing?	N/A	N/A	DWS Offset RT (in)	N/A
N/A	Gutter Ponding?	0.0	N/A	Gutter Slope (%)	N/A
N/A	Gutter Lip Ht (in)	0.0	N/A	Gutter X Slope (%)	N/A
N/A	Painted X Walk1?	No		Road Slope (%)	1.5
	X Walk 1 Direction	To NE		Road X Slope (%)	1.2
	X Walk 1 Width (in)	N/A		Clear Space?	N/A

Remove & Replace Entire Ramp.
