Access Compliance Report
Public Rights-of-Way
(Curb Ramps)

Intersection ID: 50494	Main Street: BLAIRBETH_ST	Cross Street: HAWFIELD_WAY_DR	Location:	NE
ADA ID: A0BCBC6573CF	Ramp Type: PerpDiag	Initial Pass/Fail: Fail	Overall Compliance: No	Severity Score: 25

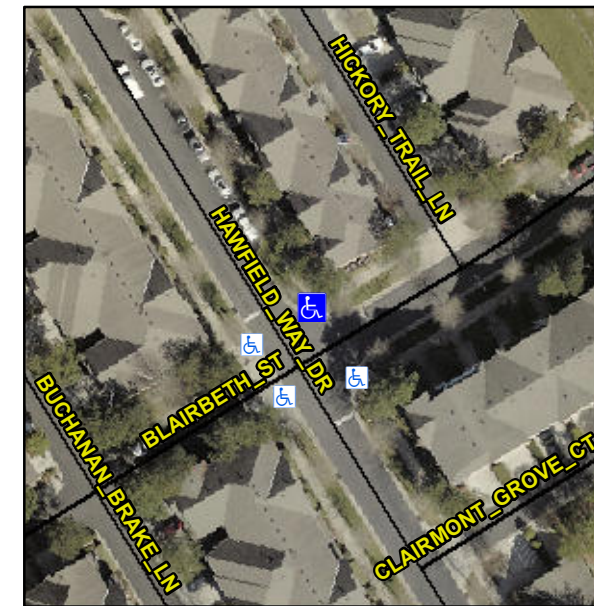
Not Found, R304.5.3

Compliance	Description	Data	Compliance	Description	Data
N/A	Ramp Length (in)	97.0	Yes	Ramp Slope (%)	6.8
Yes	Ramp Width (in)	48.0	No	Ramp XSlope (%)	7.7
N/A	Flare Type LT	N/A	N/A	Flare Type RT	N/A
N/A	Flare Slope LT (%)	N/A	N/A	Flare Slope RT (%)	N/A
N/A	Flare Traversable LT?	N/A	N/A	Flare Traversable RT?	N/A
N/A	Landing Length (in)	N/A	N/A	DWS Provided?	N/A
N/A	Landing Width (in)	N/A	N/A	DWS Contrast?	N/A
N/A	Landing Slope (%)	N/A	N/A	DWS Length (in)	N/A
N/A	Landing X Slope (%)	N/A	N/A	DWS Full Width?	N/A
N/A	Landing Curb? (Y/N)	N/A	N/A	DWS Offset (in)	N/A
N/A	Shared Landing?	N/A			
N/A	Gutter Ponding?	N/A	N/A	Gutter Slope (%)	N/A
N/A	Gutter Lip Ht (in)	N/A	N/A	Gutter X Slope (%)	N/A
N/A	Painted X Walk1?	No	N/A	Painted X Walk2?	No
	X Walk 1 Direction	To SW		X Walk 2 Direction	To SE
N/A	X Walk 1 Width (in)	N/A	N/A	X Walk 2 Width (in)	N/A
	X Walk 1 Slope (%)	2.6		X Walk 2 Slope (%)	0.0
	X Walk 1 X Slope (%)	1.2		X Walk 2 X Slope (%)	3.0

Remove & Replace Curb Ramp With Two New Directional Ramps or Equivalent.
