Access Compliance Report
Public Rights-of-Way
(Curb Ramps)

Intersection ID: 44172	Main Street: SOUTHBROOK_DR	Cross Street: BELLEGARDE_DR		Location:	NE
ADA ID: A1EC4BD1490E	Ramp Type: PerpDiag	Initial Pass/Fail: Fail	Overall Compliance: No	Severity Score:	10

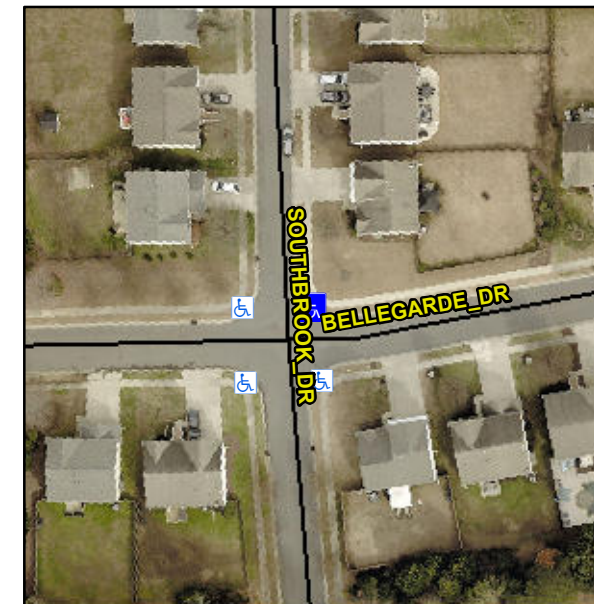
Not Found, R304.5.1, R304.5.3

Compliance	Description	Data	Compliance	Description	Data
N/A	Ramp Length (in)	48.0	Yes	Ramp Slope (%)	5.5
No	Ramp Width (in)	36.0	No	Ramp XSlope (%)	4.2
N/A	Flare Type LT	N/A	N/A	Flare Type RT	N/A
N/A	Flare Slope LT (%)	N/A	N/A	Flare Slope RT (%)	N/A
N/A	Flare Traversable LT?	N/A	N/A	Flare Traversable RT?	N/A
N/A	Landing Length (in)	N/A	N/A	DWS Provided?	N/A
N/A	Landing Width (in)	N/A	N/A	DWS Contrast?	N/A
N/A	Landing Slope (%)	N/A	N/A	DWS Length (in)	N/A
N/A	Landing X Slope (%)	N/A	N/A	DWS Full Width?	N/A
N/A	Landing Curb? (Y/N)	N/A	N/A	DWS Offset (in)	N/A
N/A	Shared Landing?	N/A			
N/A	Gutter Ponding?	N/A	N/A	Gutter Slope (%)	N/A
N/A	Gutter Lip Ht (in)	N/A	N/A	Gutter X Slope (%)	N/A
N/A	Painted X Walk1?	No	N/A	Painted X Walk2?	No
	X Walk 1 Direction	To W		X Walk 2 Direction	To S
N/A	X Walk 1 Width (in)	N/A	N/A	X Walk 2 Width (in)	N/A
	X Walk 1 Slope (%)	4.6		X Walk 2 Slope (%)	0.1
	X Walk 1 X Slope (%)	2.1		X Walk 2 X Slope (%)	2.0

Remove & Replace Curb Ramp With Two New Directional Ramps or Equivalent.
