Access Compliance Report
Public Rights-of-Way
(Curb Ramps)

Intersection ID: 49320 **Main Street:** TAVISTOCK_CT **Cross Street:** HUNTERS_MOON_LN **Location:** NW

ADA ID: A20D09417FE5 **Ramp Type:** PerpDiag **Initial Pass/Fail:** Fail **Overall Compliance:** No **Severity Score:** 21.25

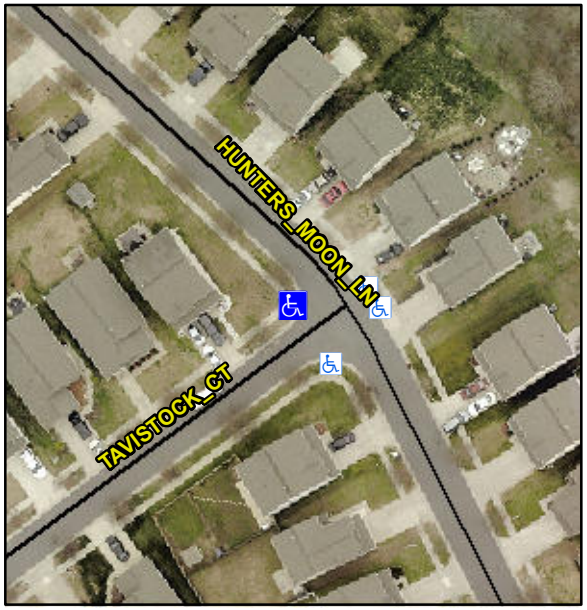
R304.5.1, R304.5.3

Remove & Replace Curb Ramp With Two New Directional Ramps or Equivalent.
