Access Compliance Report
Public Rights-of-Way
(Curb Ramps)

Intersection ID: 52716	**Main Street: AGAVA_LN**	**Cross Street: MAIDENHAIR_CT**	**Location:**	**NE**
ADA ID: A26E7266FF7D	**Ramp Type: Perp**	**Initial Pass/Fail: Pass**	**Overall Compliance: No**	**Severity Score: 2.5**

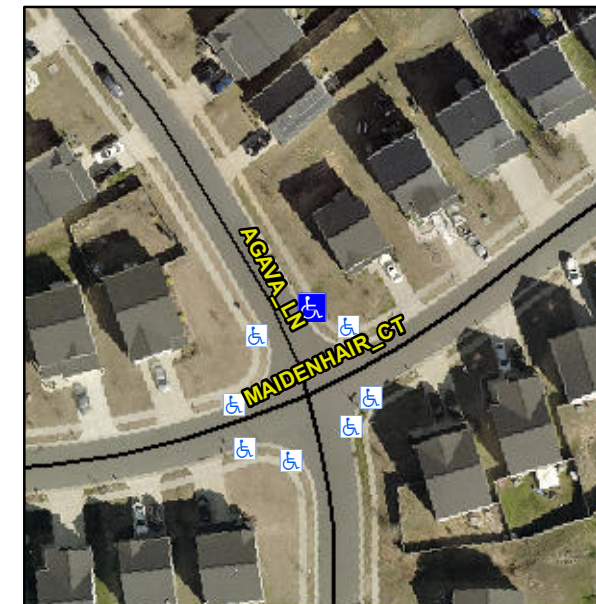
Not Found, R304.2.1, R304.5.3, R305.1.4, R305.2

Compliance	Description	Data	Compliance	Description	Data
N/A	Ramp Length (in)	47.0	Yes	Ramp Slope (%)	6.5
Yes	Ramp Width (in)	48.0	Yes	Ramp XSlope (%)	1.2
N/A	Flare Type LT	Sloped	N/A	Flare Type RT	N/A
N/A	Flare Slope LT (%)	2.4	N/A	Flare Slope RT (%)	5.0
N/A	Flare Traversable LT?	No	N/A	Flare Traversable RT?	No
No	Landing Length (in)	46.0	Yes	DWS Provided?	Yes
Yes	Landing Width (in)	48.0	Yes	DWS Contrast?	Yes
Yes	Landing Slope (%)	0.5	Yes	DWS Length (in)	24.0
No	Landing X Slope (%)	2.4	No	DWS Full Width?	No
N/A	Landing Curb? (Y/N)	No	No	DWS Offset (in)	3.0
N/A	Shared Landing?	No			
Yes	Gutter Ponding?	No	Yes	Gutter Slope (%)	2.0
Yes	Gutter Lip Ht (in)	0.0	No	Gutter X Slope (%)	2.3
N/A	Painted X Walk1?	No	N/A	Painted X Walk2?	N/A
	X Walk 1 Direction	To W		X Walk 2 Direction	N/A
N/A	X Walk 1 Width (in)	N/A	N/A	X Walk 2 Width (in)	N/A
	X Walk 1 Slope (%)	1.6		X Walk 2 Slope (%)	N/A
	X Walk 1 X Slope (%)	2.2		X Walk 2 X Slope (%)	N/A

N/A	Ramp inside XWalk1?	N/A	N/A	Ramp inside XWalk2?	N/A
	Road Slope (%)	N/A	N/A	Clear Space?	Yes
	Road X Slope (%)	N/A	N/A	Clear Space to XWalk (in)	N/A
Yes	Any Obstructions?	No	Yes	Storm Grate/Utility Hazard?	No
	Obstruction Type			Storm Grate/Utility Type	
N/A					N/A
			Yes	Surface Condition? (G/P)	Good

Remove & Replace Entire Ramp.
Remove & Replace Gutter.
