Access Compliance Report

# Public Rights-of-Way
(Curb Ramps)

Intersection ID: 47468	Main Street: MILLSTREAM_RIDGE_DR	Cross Street: ELENDIL_LN	Location:	SW
ADA ID: A28A5CA25305	Ramp Type: PerpDiag	Initial Pass/Fail: Fail	Overall Compliance: No	Severity Score: 22.5

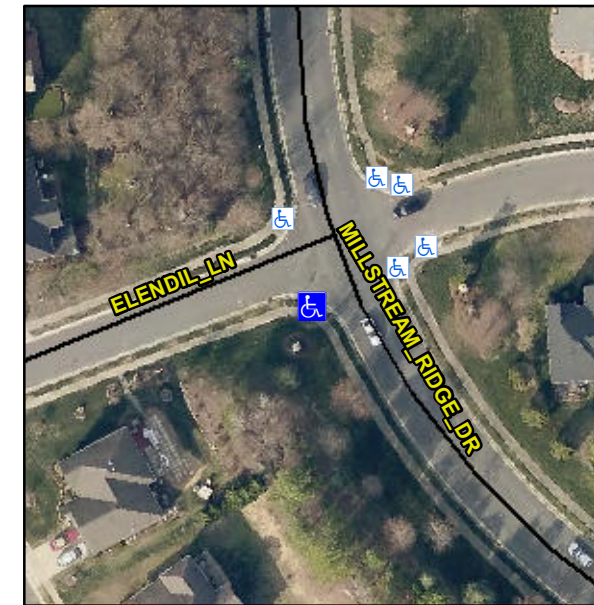
R304.5.1, R304.2.2, R304.5.3

Compliance	Description	Data	Compliance	Description	Data
N/A	Ramp Length (in)	48.0	No	Ramp Slope (%)	9.1
No	Ramp Width (in)	44.0	No	Ramp XSlope (%)	2.8
N/A	Flare Type LT	N/A	N/A	Flare Type RT	N/A
N/A	Flare Slope LT (%)	N/A	N/A	Flare Slope RT (%)	N/A
N/A	Flare Traversable LT?	N/A	N/A	Flare Traversable RT?	N/A
N/A	Landing Length (in)	N/A	N/A	DWS Provided?	N/A
N/A	Landing Width (in)	N/A	N/A	DWS Contrast?	N/A
N/A	Landing Slope (%)	N/A	N/A	DWS Length (in)	N/A
N/A	Landing X Slope (%)	N/A	N/A	DWS Full Width?	N/A
N/A	Landing Curb? (Y/N)	N/A	N/A	DWS Offset (in)	N/A
N/A	Shared Landing?	N/A			
N/A	Gutter Ponding?	N/A	N/A	Gutter Slope (%)	N/A
N/A	Gutter Lip Ht (in)	N/A	N/A	Gutter X Slope (%)	N/A
N/A	Painted X Walk1?	No	N/A	Painted X Walk2?	No
	X Walk 1 Direction	To E		X Walk 2 Direction	To N
N/A	X Walk 1 Width (in)	N/A	N/A	X Walk 2 Width (in)	N/A
	X Walk 1 Slope (%)	0.6		X Walk 2 Slope (%)	6.1
	X Walk 1 X Slope (%)	6.6		X Walk 2 X Slope (%)	0.1

Remove & Replace Curb Ramp With Two New Directional Ramps or Equivalent.
